BINNING HOUSE

2968 MATHERS CRESCENT, WEST VANCOUVER

CONSERVATION PLAN

APRIL 2017

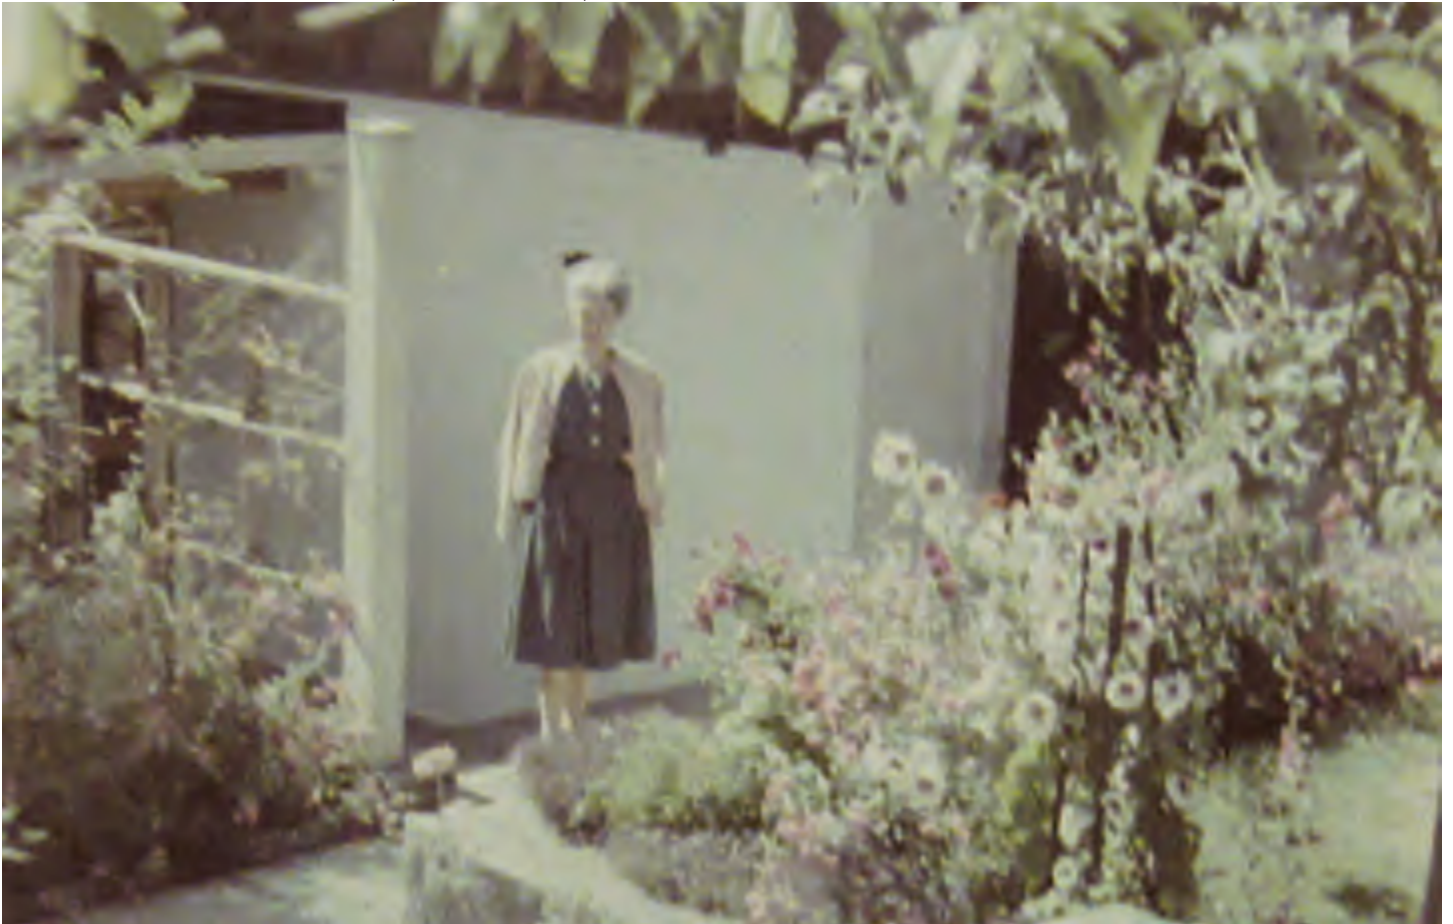
Jessie in front of house, note the unpainted mural wall, slide in colour, 1941, Vancouver Art Gallery Archives

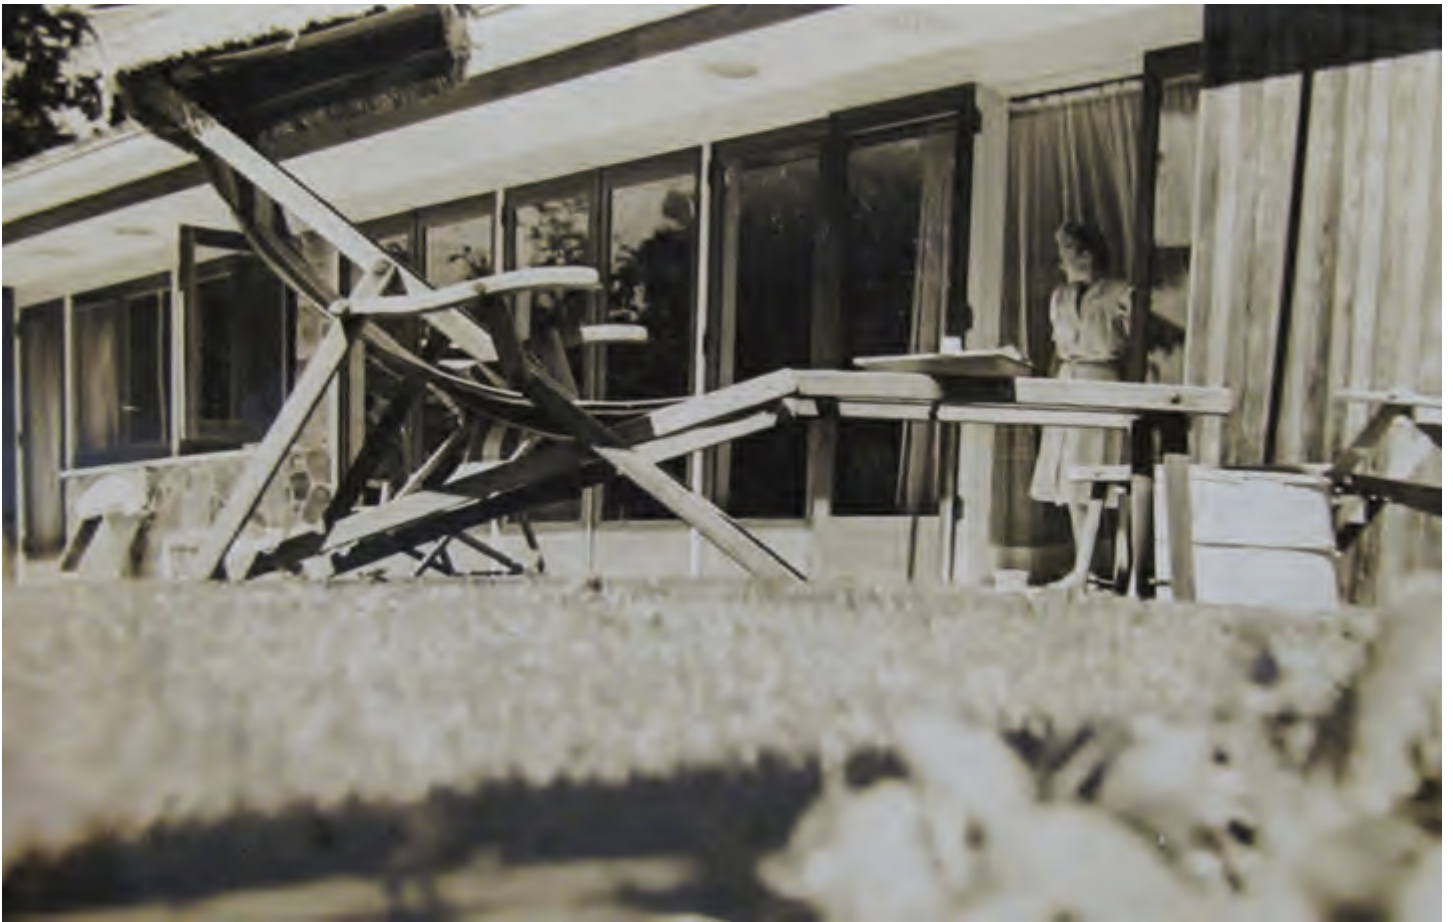
Terrace, overlooking Jessie, Bert says 'note combination of stone and wood,' Vancouver Art Gallery
