Conservation Approach

The Woyat-Bowie Building 660 Clyde Avenue, West Vancouver, BC

Condition Assessment

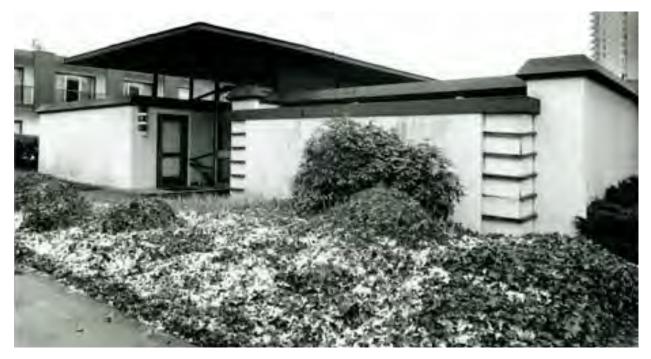
Above: The building c. 1988 showing the Clyde Avenue frontage, original corner box lights and the landscaping West Vancouver Archives photo 2586 0018 DWV

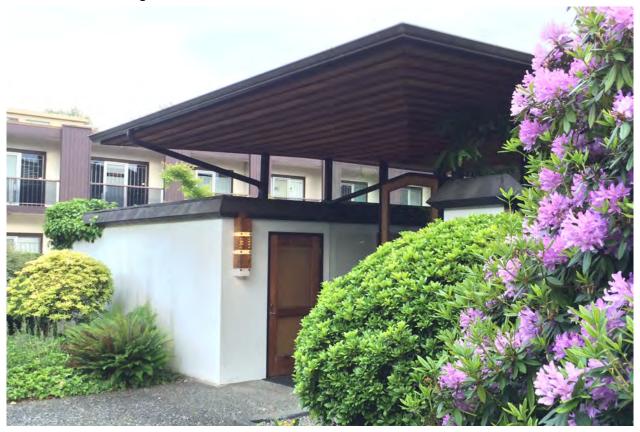
Below: The building in 2016

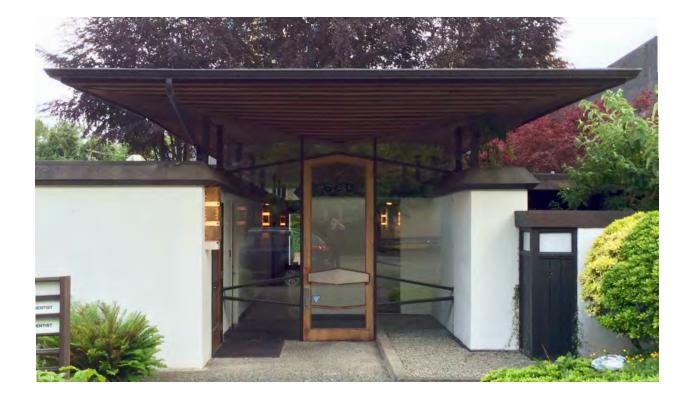
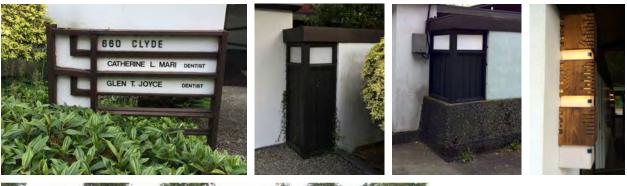
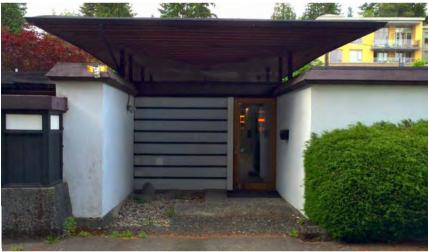
Top: Front entrance showing the front door, roof and passage through the building

Middle: address sign board, corner box lights, and sconce at the front entrance

Bottom: Rear entrance showing roof, plexiglass and wood rear panel

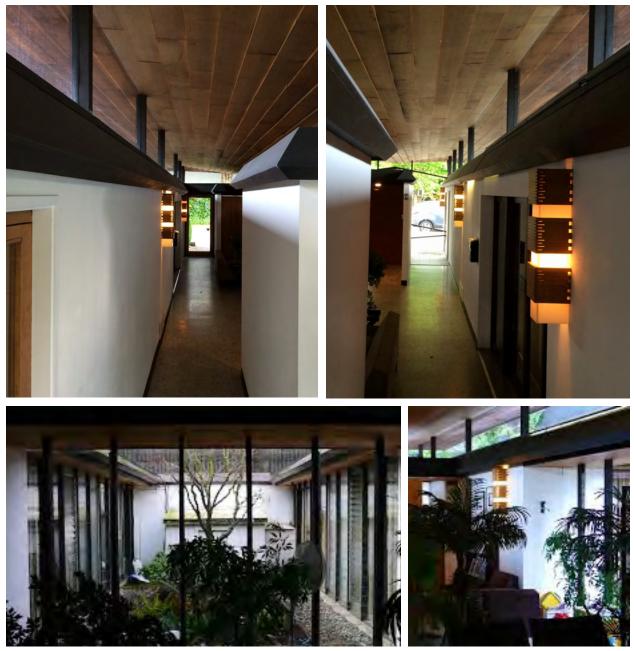
Top left: the corridor view from the front door **right:** view from the rear of the building Bottom left: the central courtyard garden with offices arranged around the north and south sides Bottom right: lobby area and courtyard garden
