Diamond Head Consulting Ltd. Tree Assessment

For: 4719 Pilot House Road
West Vancouver, BC

April 2, 2014

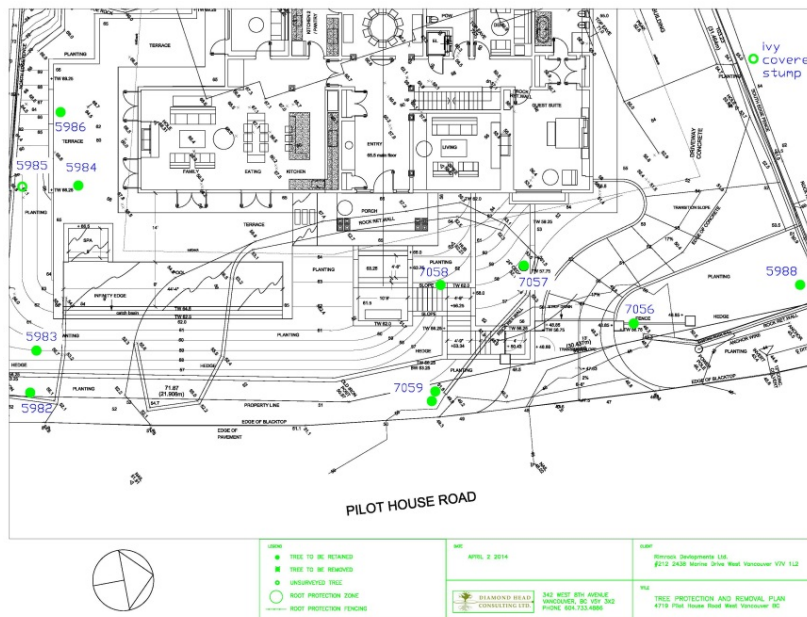
The subject tree is a Western redcedar (#7059) located east of the subject site's property line. This tree is located at the edge of the driveway as well as the edge of Pilot House Road and within the limits of the overhead BC Hydro power line.

Figure 1. Location of the subject tree #7059 located on District property adjacent 4719 Pilot House Road West Vancouver
