Arborist Report

File #:	22-077
Date:	22 July 22
Weather:	Overcast
Client:	Somerset Homes
Telephone:	604-671-5202
Email:	shawn@somersetcustomhomes.ca
Site Address:	2225 Folkestone Way, West Vancouver, British Columbia V7S 2Y6

Burley Boys Tree Service Ltd. has been contracted to provide a preliminary tree removal/retention outline for the property at 2225 Folkestone Way, West Vancouver, BC. Plans for the property include the redevelopment of the existing commercial building on the property & construction of a new multi-unit, mixed use building.

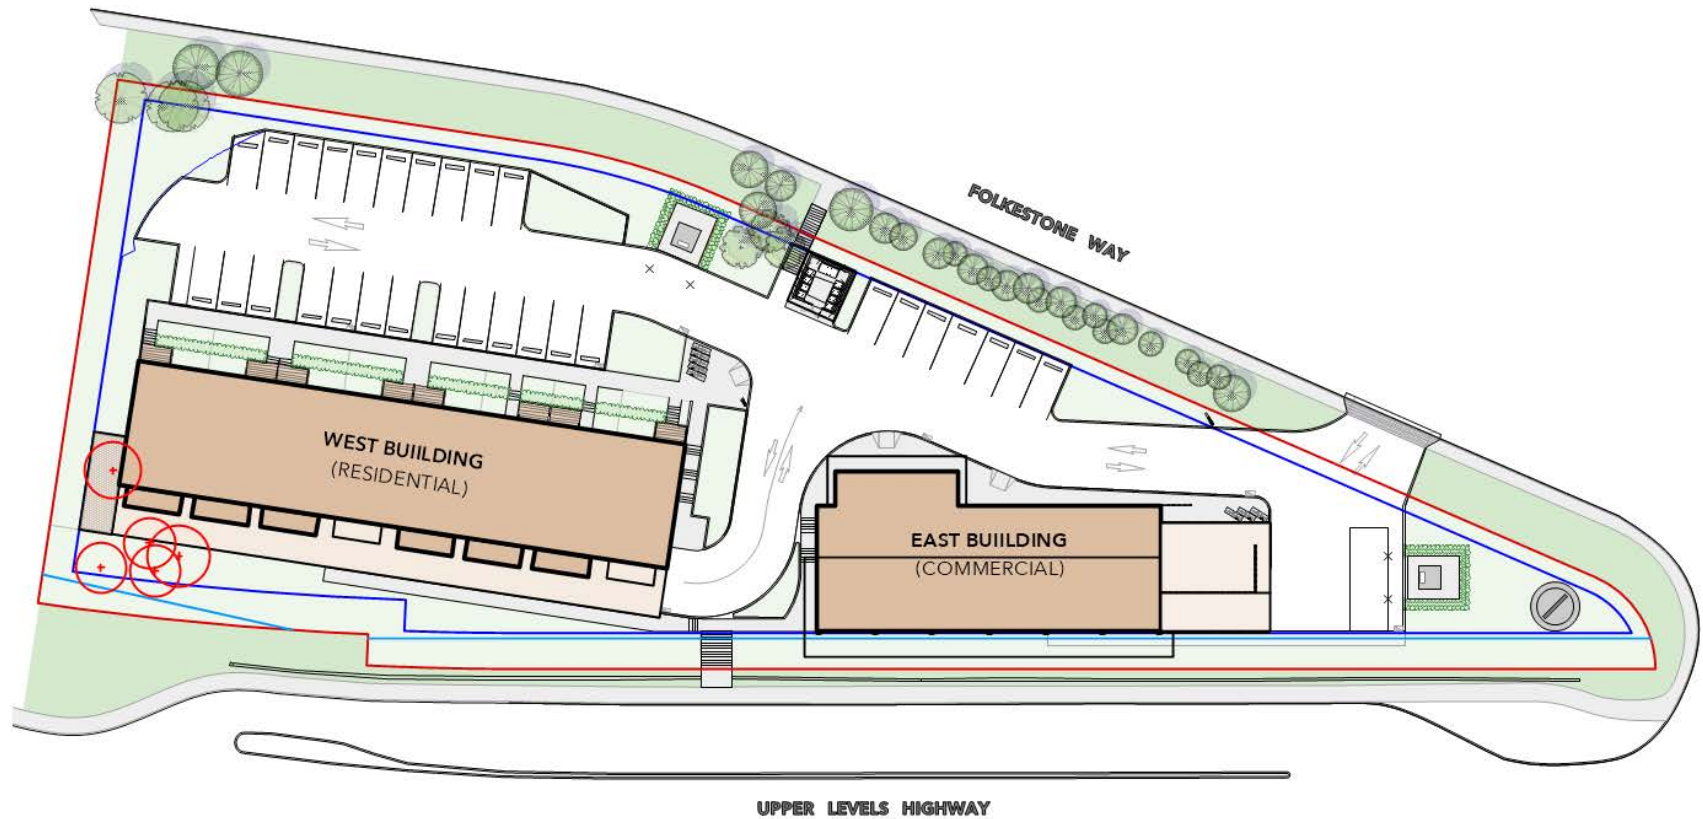
Site Plan:

An original large scaled copy of the site plan indicating trees marked for removal, and the locations of Tree Protection Zone fencing has not been included with this report; this is to be provided by the applicant, if required.

— TREES TO BE REMOVED
