DISTRICT OF WEST VANCOUVER
750 17TH STREET, WEST VANCOUVER BC V7V 3T3

COUNCIL REPORT

Date:	January 20, 2026
From:	Matthew O'Connor, Bylaw and Licensing Services Manager
Subject:	6507 Nelson Avenue – <i>Community Charter</i> Remedial Action Requirement

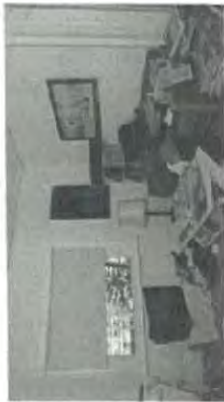
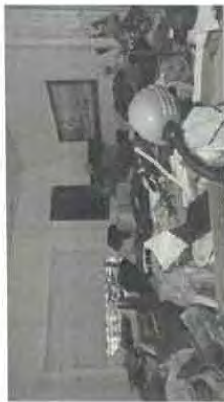
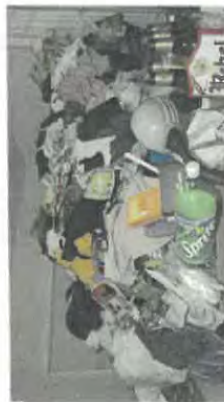
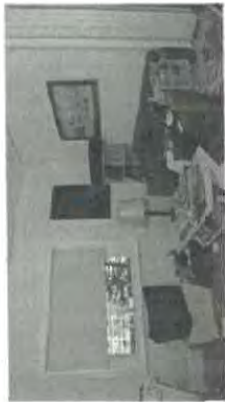
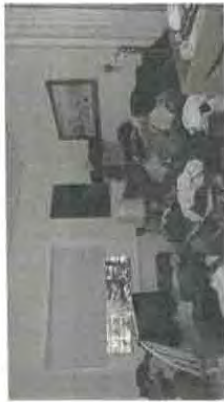
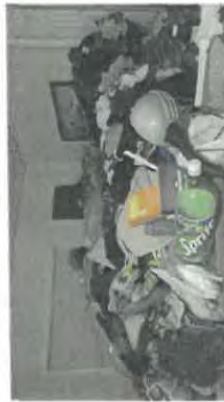
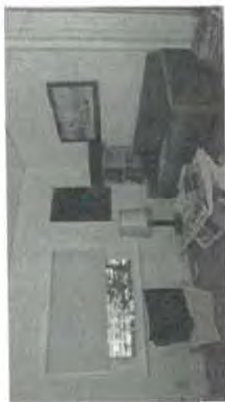
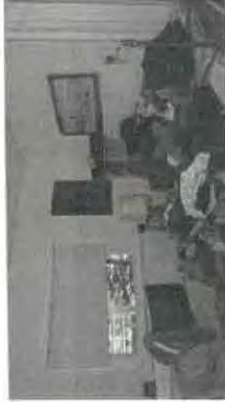
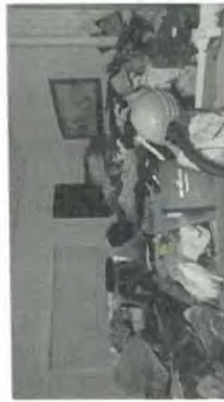
Clutter Image Rating Scale

- Unsecured derelict/abandoned structure
- Overgrown and waste on exterior
- Steep slope with residential above
- Forested green space adjacent behind property
- Residential inspection of interior shows Significant Fire Risk.

COMMENTS:

Interior assessment determines home
predominately 7-9 on hoarding scale

- Remove remaining storage from utility room that contains furnace and hot water tank.
 - o This will assist the technician with any repairs the appliances might need.
- Create at least one meter of travel width along hallways, staircases and balconies.
 - o This will assist occupants in faster escape should there be a fire.
- Limit vertical storage piles to manageable levels so they cannot tip over onto occupants.
- Have at least one working smoke alarm per level of your home.
- Have at least one working fire extinguisher per level of your home.
- Limit storage items on top of stove to minimize risk of fire.
- Have your home checked for rodent infiltration
 - o Rodents can chew on electrical wiring and cause fires.
