DISTRICT OF WEST VANCOUVER
750 17TH STREET, WEST VANCOUVER BC V7V 3T3

COUNCIL REPORT

Date:	May 12, 2024
From:	Jenn Moller, Director of Engineering & Transportation Services
Subject:	Eagle Island Access Infrastructure
File:	1700.09

STRUCTURE ID: 401 – MAINLAND DOCK

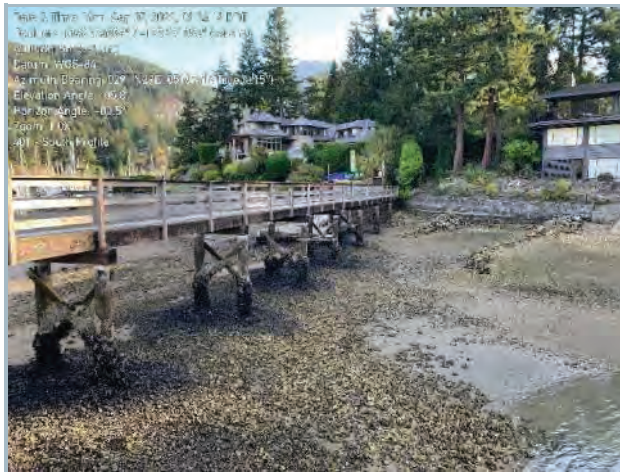
The cross-bracing on the piers is in poor condition and almost completely failed on some piers. The seismic demands are likely low due to the low seismic mass (the structure is entirely timber or aluminum), but the structure does not have a reliable seismic force resisting system, and therefore is likely moderately vulnerable to seismic loading.

009. Braced Timber Piers, Typ.

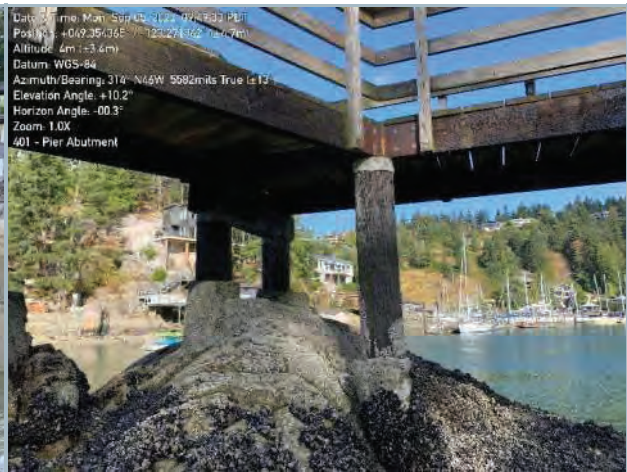
010. West Pier Abutment on Bedrock

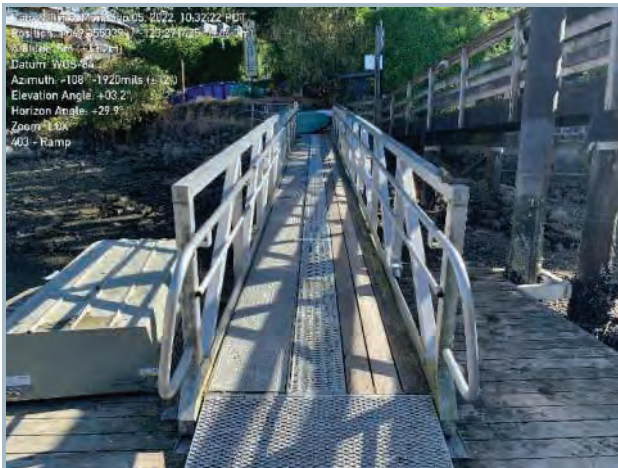
003. East Approach Gangway Viewing East

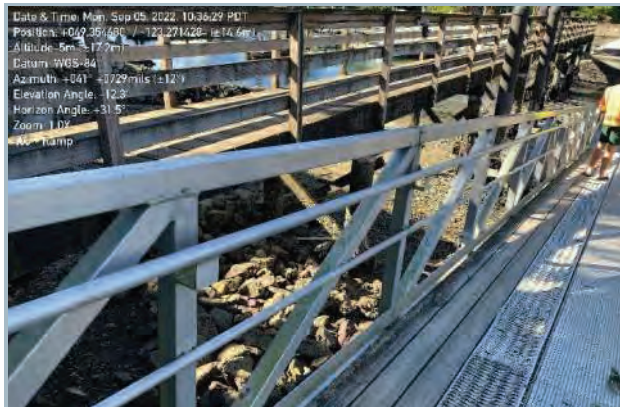
007. Gangway Railing & Truss Orientation

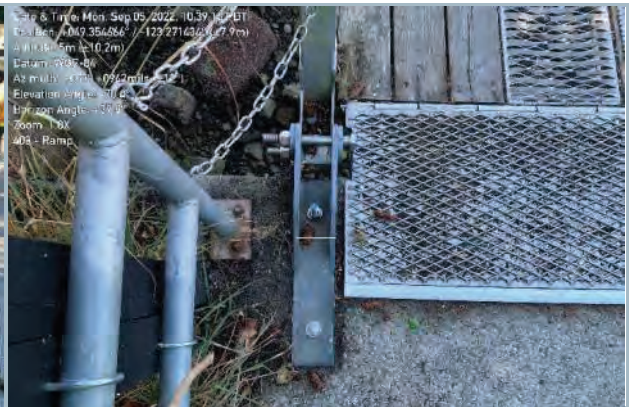
008. Gangway Connection to East Abutment

Reposition or replace bearing pins at aluminum ramp.

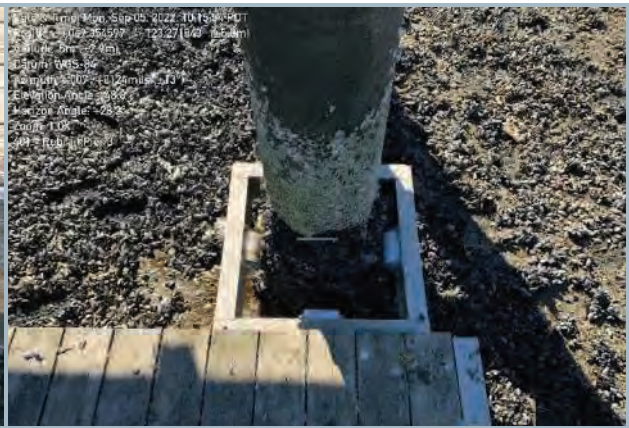
010. Dock Restraint Timber Pier Connection
