# SYKES RESIDENCE

5616 WESTPORT PLACE, WEST VANCOUVER  
CONSERVATION PLAN

NOVEMBER 2014

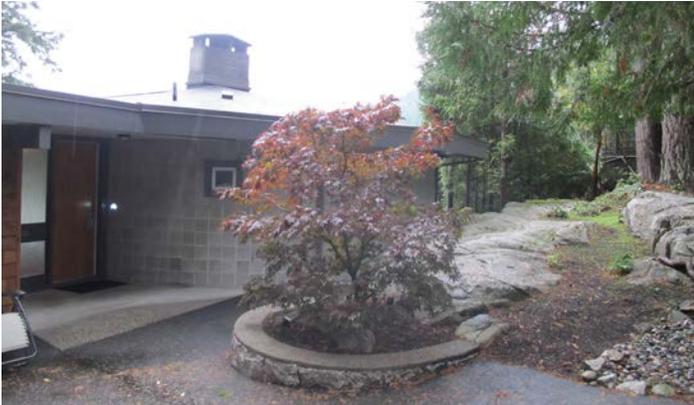
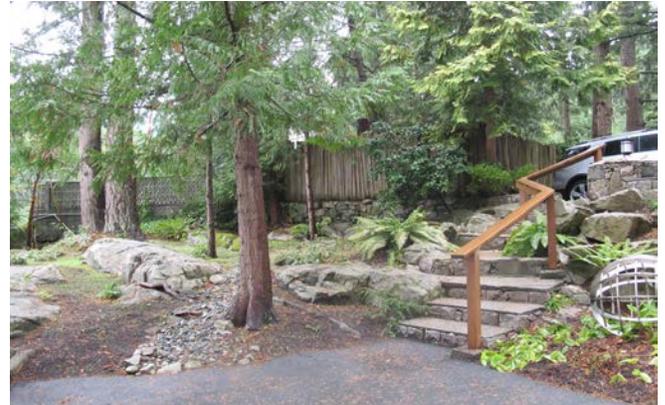
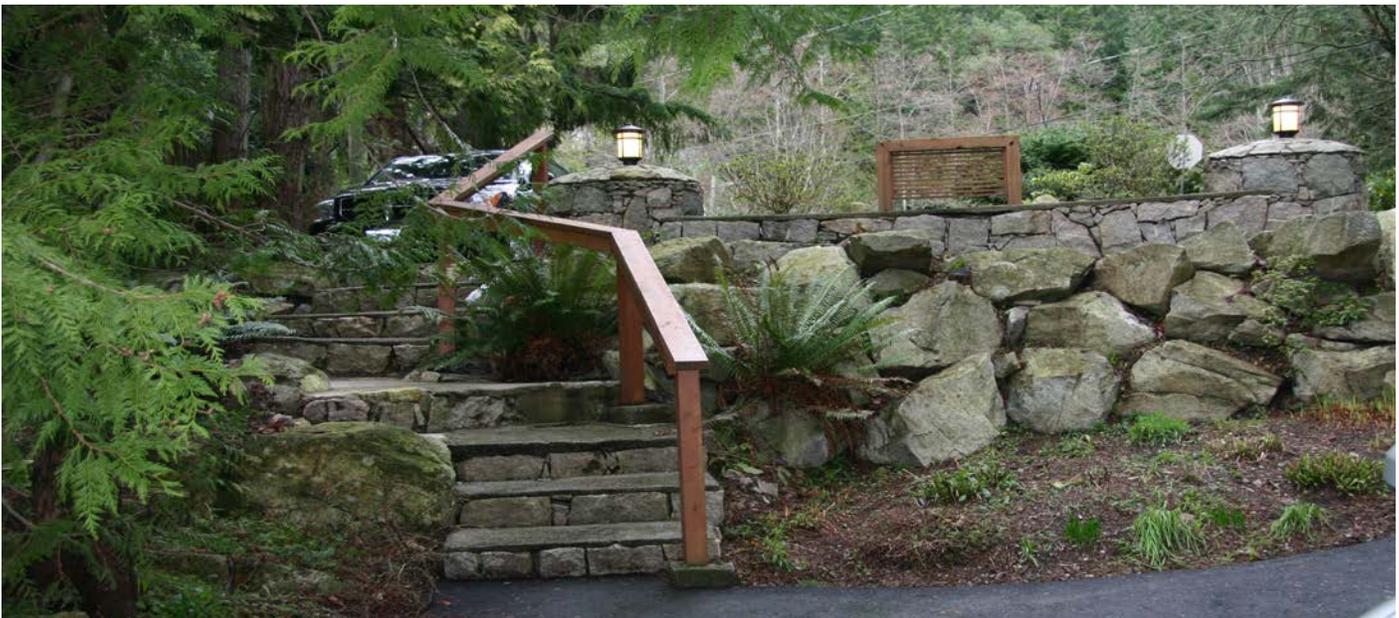
Original landscape features at the front of the house including original stone walls, steps and light pillars.

- Preserve the historic house in its original location.
- Future work should consider the retention of landscape features including stone walls and light pillars at the front of the house. Repair deteriorated elements with appropriate in-kind materials where necessary.
- Potential geotechnical instabilities caused by mature vegetation should be carefully mitigated and coordinated by a professional engineer.
- The new addition on the subdivided lot is adequately located on the site and preserves the expansive views from the historic house.
- The design of the new addition should be compatible with, distinguishable from and subordinate to the historic house. The design of the new addition should follow recommendations listed in the Parks Canada *Standards and Guidelines* (4.3 General Conservation Strategy).

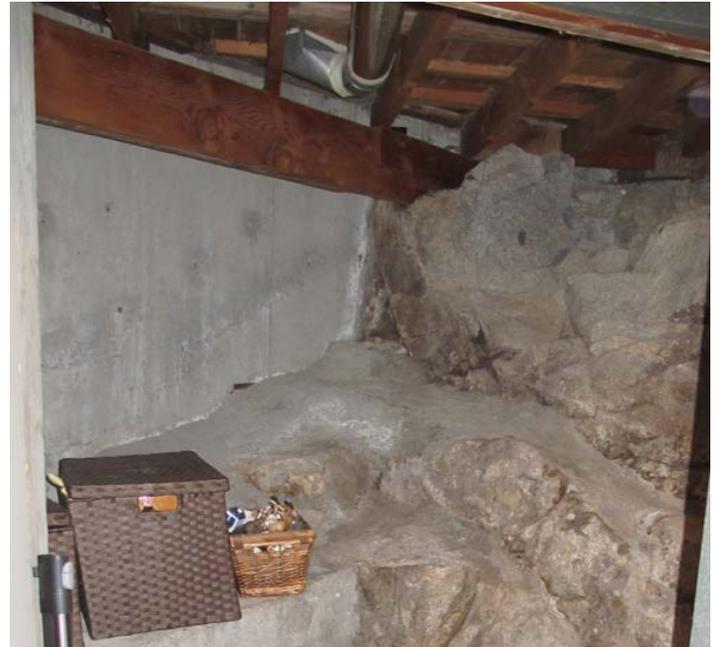
Concrete foundation wall built into bedrock

- Preserve the historic foundation walls, concrete pillars and stone retaining walls.
- Carefully remove ivy from the stone retaining wall. Rake loose mortar and repoint with suitable mortar of lower compressive strength than the existing granite blocks. Mortar colour to match existing.
- If future seismic upgrades or structural interventions are contemplated, the work should not diminish character-defining elements and the design should be sympathetic to the historic character of the house.

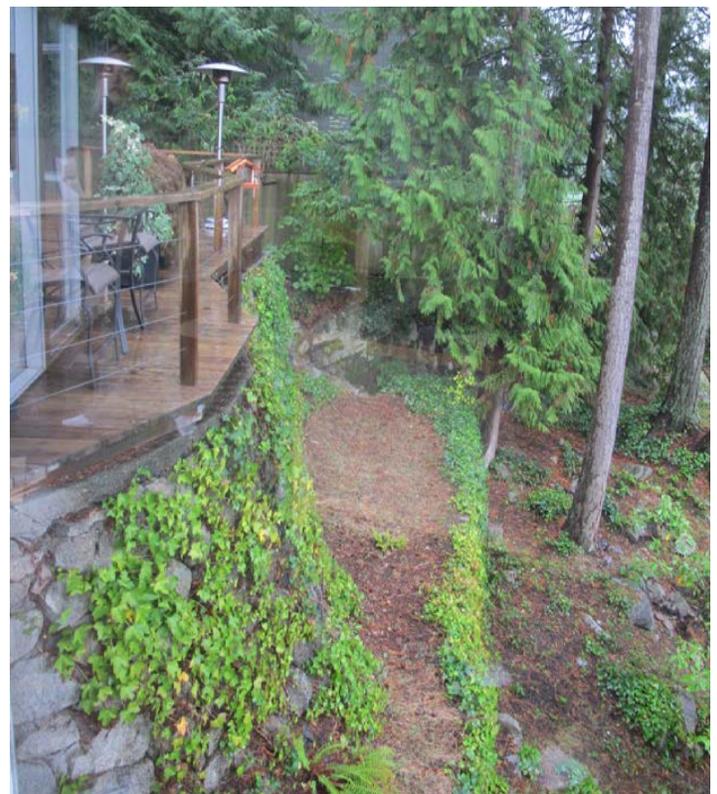
terrain was basically preserved except for retaining walls and concrete pillars to support the elevated home. A preliminary geotechnical site assessment suggests that rootwork of some mature trees on the south side of the house may have caused instability to sections of the bedrock and remedial work may be required.

Grade changes on the south side of Sykes Residence

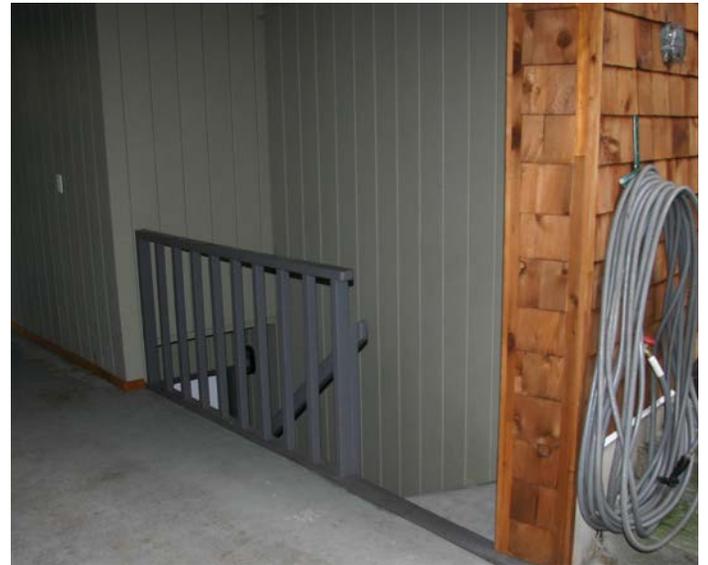
Carport walls finished with original wood siding

- Original vertical cedar siding should be preserved as a character-defining element.
- If deterioration will be detected in the future, damaged material should be restored in place. Only severely damaged or deteriorated panels should be replaced with new siding to match original in material, size, profile and thickness.
