PROJECT: 4719 PILOT HOUSE ROAD  
 TITLE: LOCATION PLAN  
 SCALE: NOT TO SCALE  
 DATE: 1 JUNE 2014  
 ISSUED: CAULFIELD PANEL REVIEW  
 DRAWING # **1**

PROJECT: 4719 PILOT HOUSE ROAD  
 TITLE: EXISTING HOUSE CONTEXT  
 SCALE: NOT TO SCALE  
 DATE: 1 JUNE 2014  
 ISSUED: CAULFIELD PANEL REVIEW

PROJECT: 4719 PILOT HOUSE ROAD  
 TITLE: NEW HOUSE CONTEXT  
 SCALE: NOT TO SCALE  
 DATE: 3 JUNE 2014  
 ISSUED: CAULFEILD PANEL REVIEW

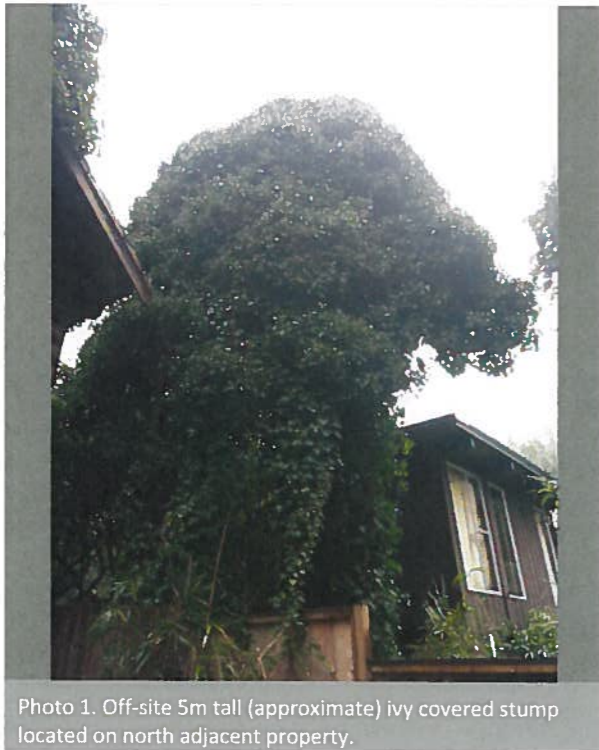
There is a 5m high stump located on the adjacent north property; the neighbours should be consulted about removing this stump prior to construction on the subject site. There are no other off-site trees that are within the zone of influence to the subject site.
