# THE STEWART - LOUGH RESIDENCE

5768 Larson Place, West Vancouver, British Columbia

STATEMENT OF SIGNIFICANCE & BACKGROUND  
APRIL 2022  
CONSERVATION PLAN  
NOVEMBER 2022

### I. Condition Survey

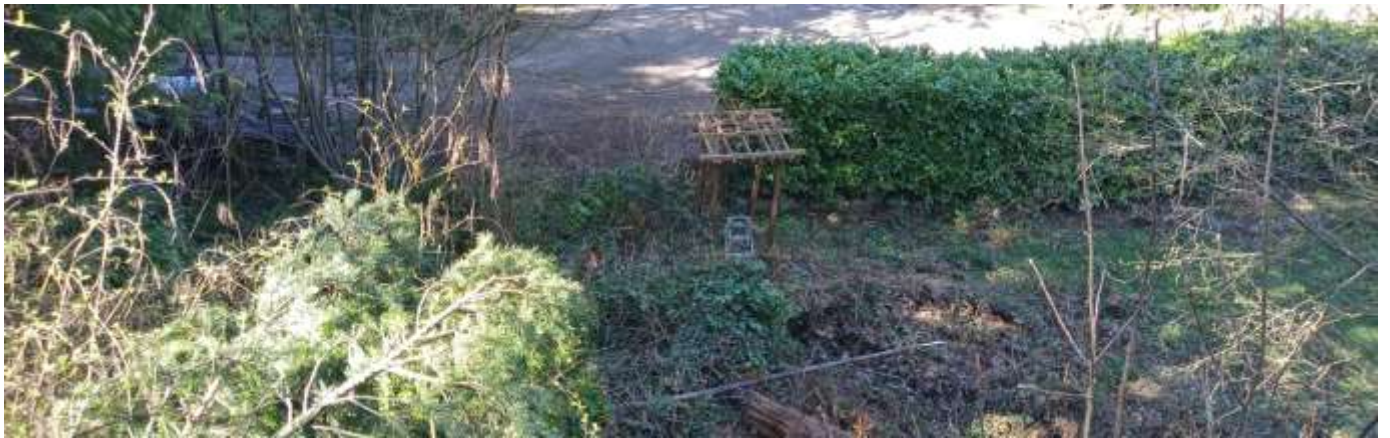
The lower slope of the current property is steep and deprived of major trees, typically found in the area. A neglected wooden gate stands at the lower Larson Place's Street frontage. The pathway up to the house has not been maintained and there are no visible traces of the original driveway. The view of the house from lower Larson Place is compromised by the deck extension and its heavy wooden balustrade, which is incongruous to the original structure. The play of the skewed roof geometry, however, is still visible above the deck.

Figure 70: Gate seen from Stewart-Lough deck

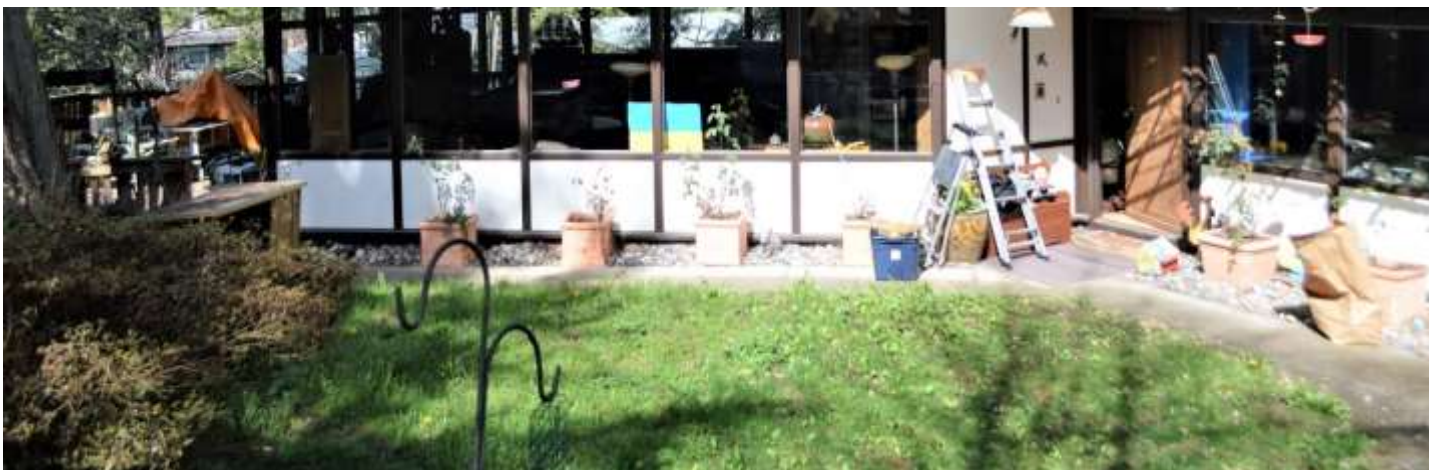
Figure 73: Forecourt lawn and concrete pathway

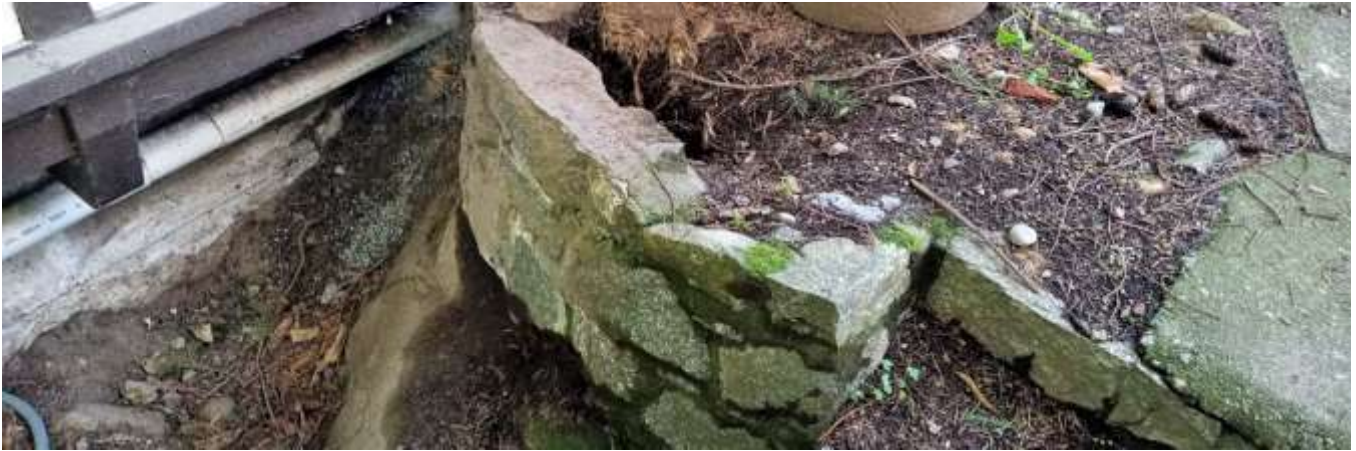
Other features highlight the outdoor spaces, such as curved stone steps. The house was designed as if it hovers over the land, due to exposed crawl spaces and point load footings. The house is nested into an embankment on the east side. The rock face visible from several rooms of the house is also an important feature of the property. The landscaping elements of the Stewart-Lough house have been neglected and cluttered with tools and furniture. Missing flag stones, damaged wood planks and rusty metal is omnipresent around the house.

Figure 74: North side terrace stone steps edge

The circular metal railing on the north side of the house should be maintained and refurbished; the rust should be removed, the surfaces cleaned, the railing stabilized and refinished in matching colour. Flag stone surfaces on the north side of the house should be extended to the entire space defined by the circular metal railing. The wood deck structure should be reviewed by a qualified engineer, especially the 1970’s deck extension; the removal of the 1970’s deck extension should be considered. The deck floor should be reviewed and repaired where required with matching material, in kind, size and profile. Replacing the existing wood railing with a lighter metal one should also be considered. The concrete walkway from the deck to the entrance, and street should be kept and the existing lawn maintained. Loose and cracked concrete should be repaired if possible or replaced in parts with matching material. Steps from the walkway to the wooden deck, and the street should be maintained. The stone steps to the street should be rehabilitated with matching material. Stone walls and stair features should be rehabilitated with matching material, in size and design. Outdoor spaces should be clear of debris, extraneous tools and furniture.

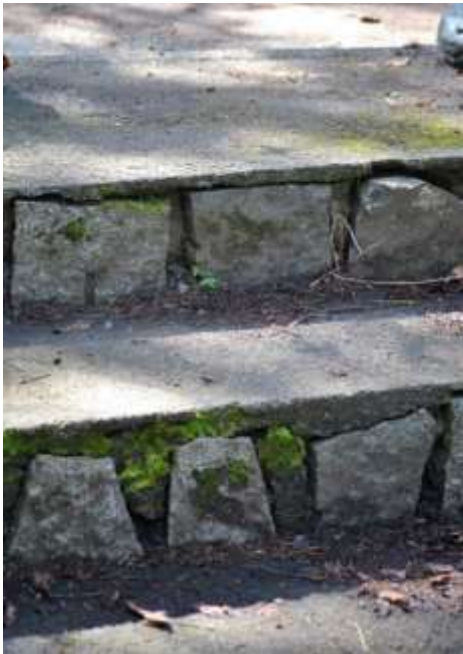
Figure 75: Stone steps from forecourt to Larson Place

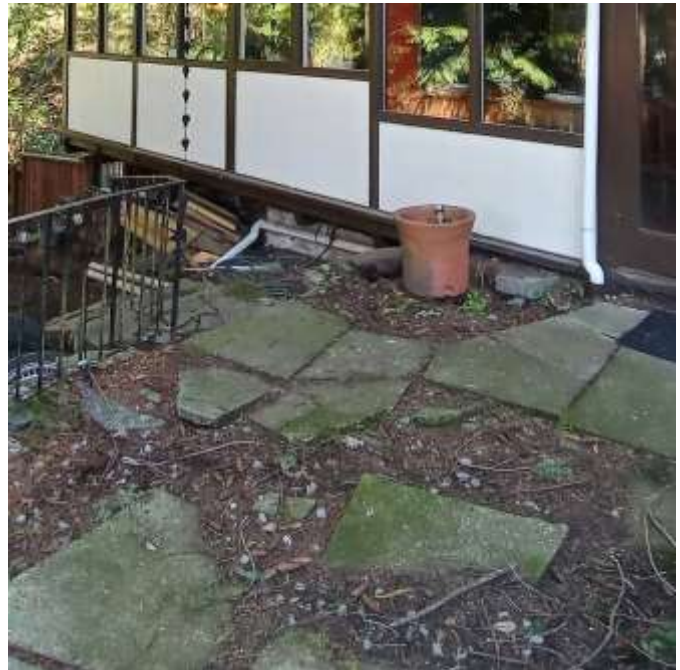
Figure 76: Flag stones at north side terrace

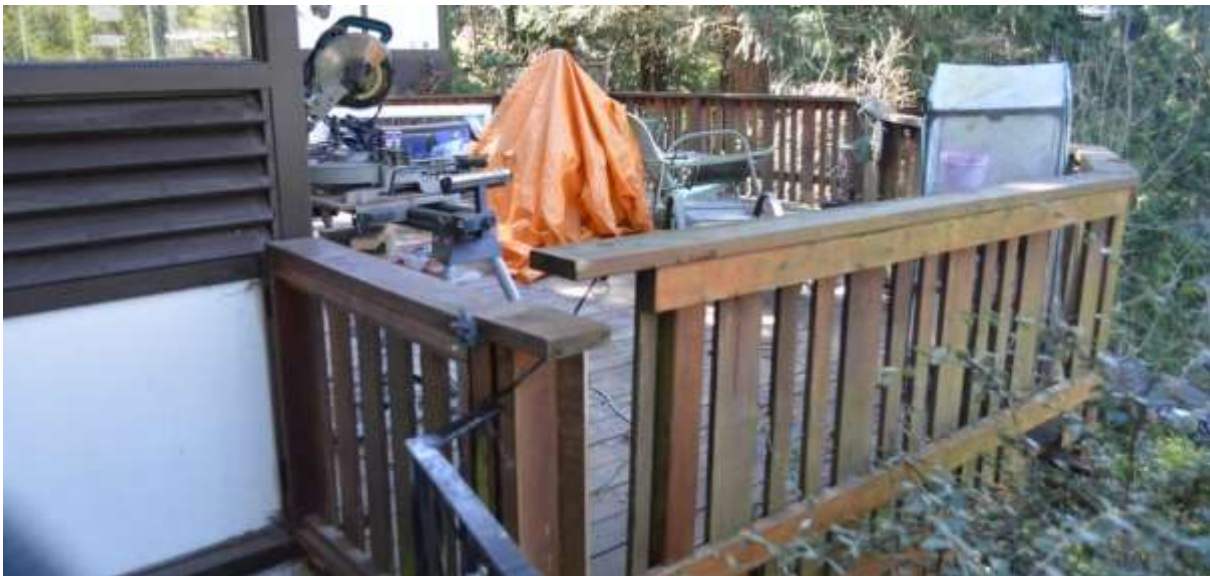
Figure 80: Wood railing around deck with gate to north side terrace

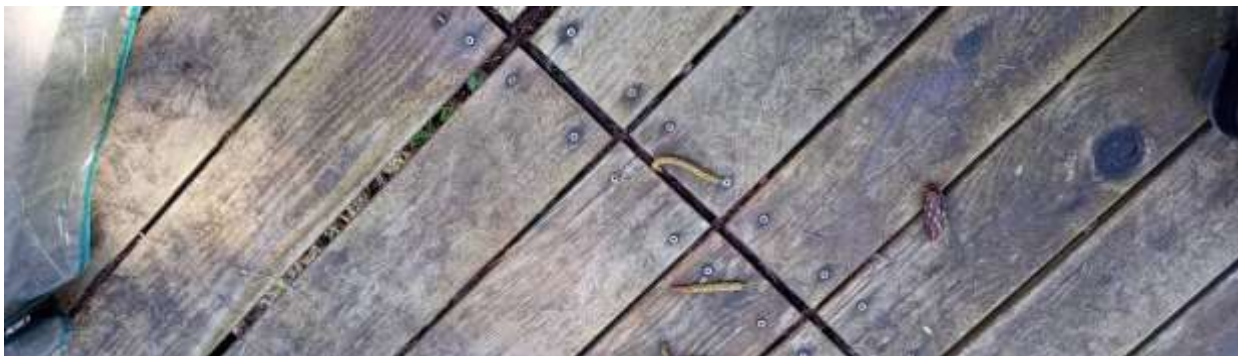
Figure 81: Wooden board deck floor

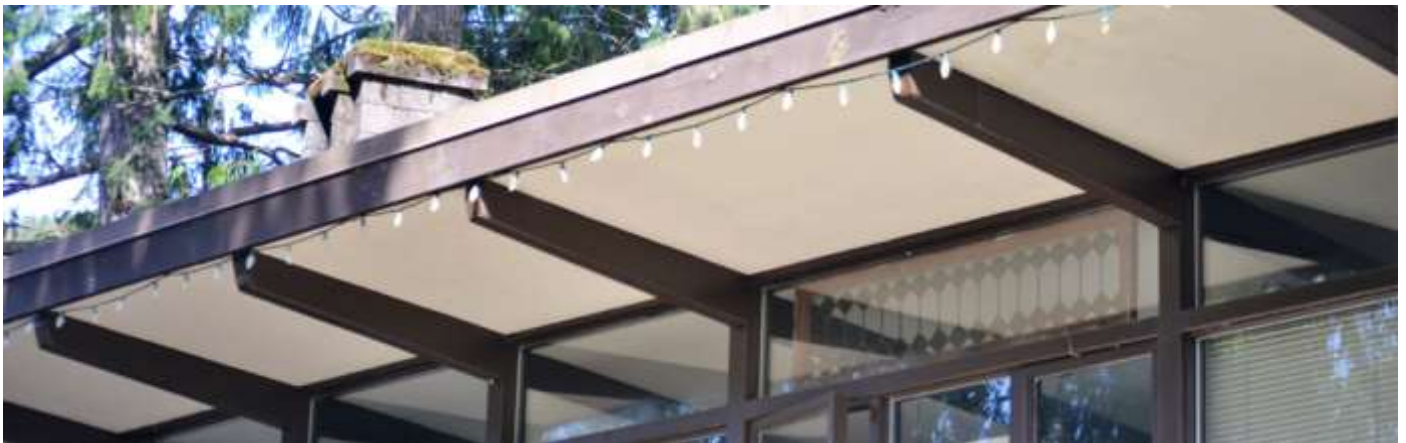
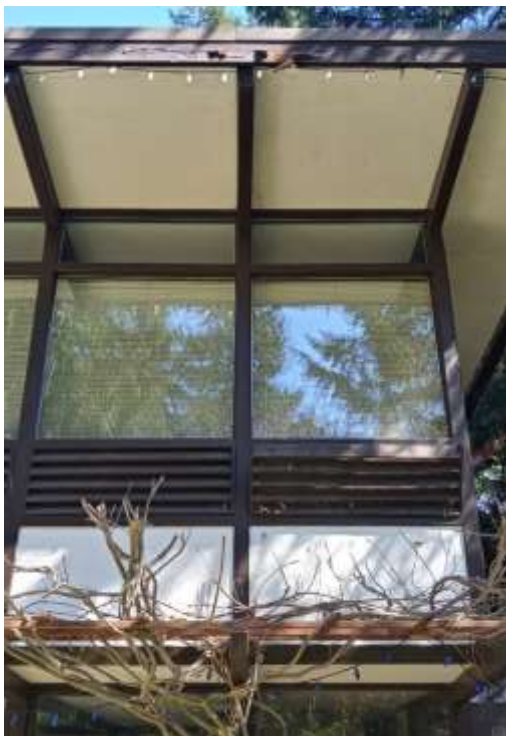
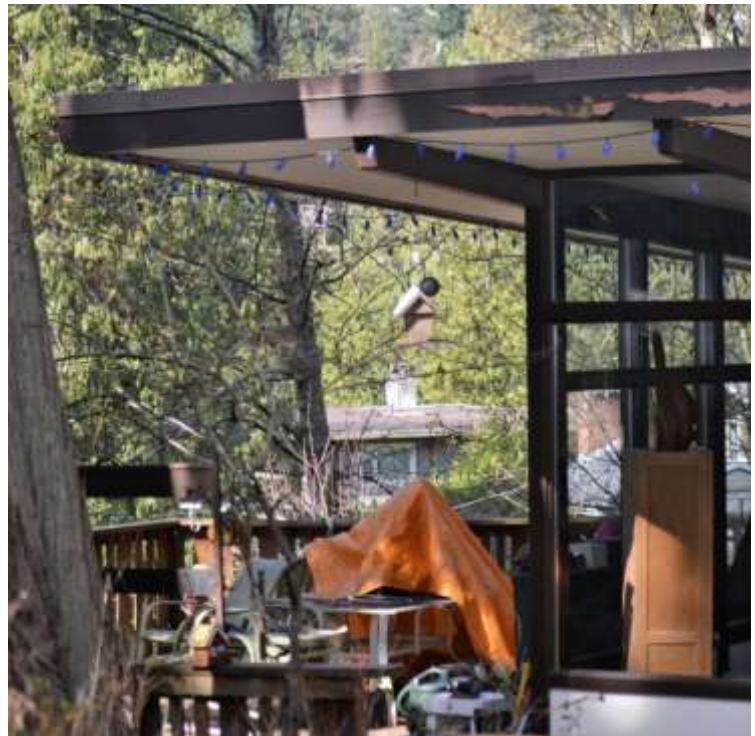
Figure 88: Roof overhang with exposed rafters

Figure 89: Roof overhang with exposed rafters

Figure 90: Corner detail of roof overhang

6. **Fascia boards; Rehabilitation/preservation:** The roof fascia boards should be refinished since paint is peeling and chipping at several locations. Paint colour should match the existing. Damaged boards should be replaced with matching material, in kind, size and profile; entire lengths should be provided; patching is not acceptable.

7. **Rafters; Preservation:** Exposed continuous rafters inside and outside should be preserved. The colour and finish of the rafters should be maintained as existing. The rafter tail profile should be preserved. Damaged rafters should be replaced with material matching the existing, in kind, size and profile; localized repairs are acceptable in the case of rafters.

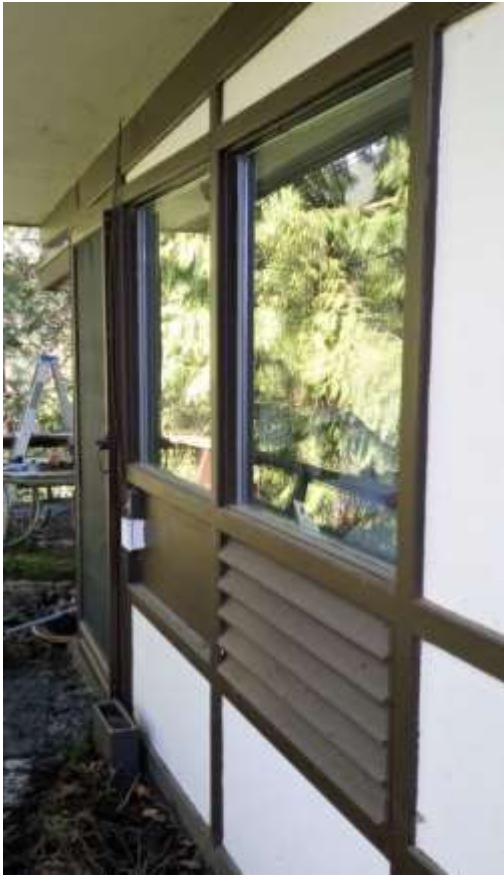
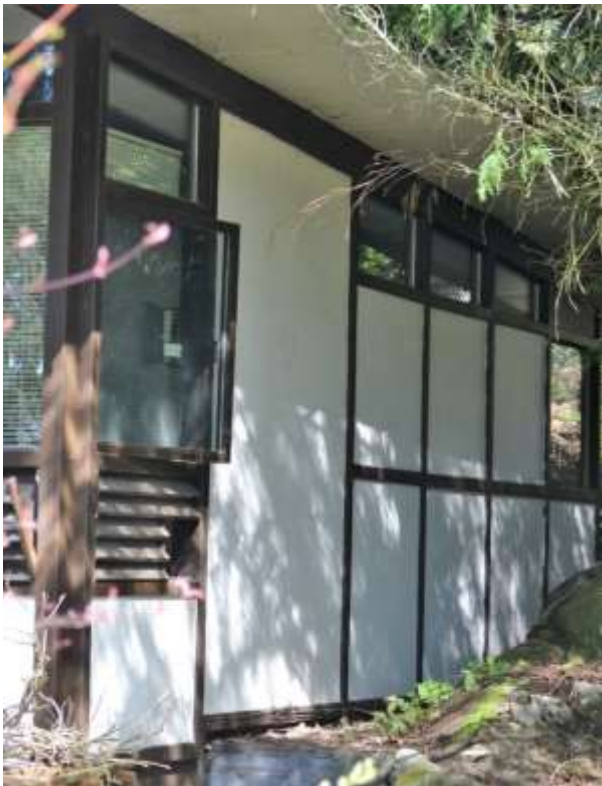
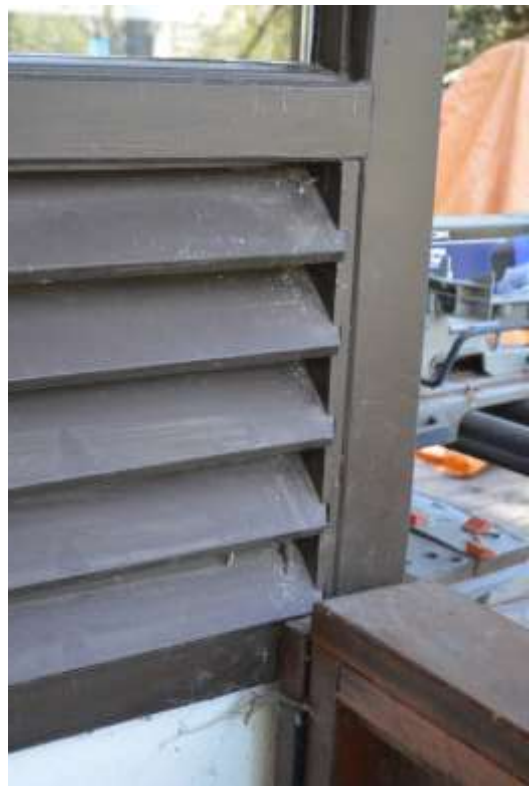
Figure 96: Wall panels, louvers, windows and transom

Figure 98: Exterior wall panels

Figure 99: Continuous louver

12. **Exterior panelling; Rehabilitation/Restoration:** The exterior wall assembly should be preserved. Repairs to the exterior walls should only include matching material and composition. If insulation is found inside the wall a review by a building envelope specialist should be considered; a hazardous material investigation should also be initiated.

preserved. Bug screens should also be repaired where needed. The continuous wooden louvers in front of the ventilators should be dismantled if required, cleaned and refinished to allow free movement of air through ventilators. The exterior wooden louvers should be maintained; missing lengths should be replaced with matching material, in kind, size, and profile. Unless a different original colour is found, the paint colour should be the same as the existing.

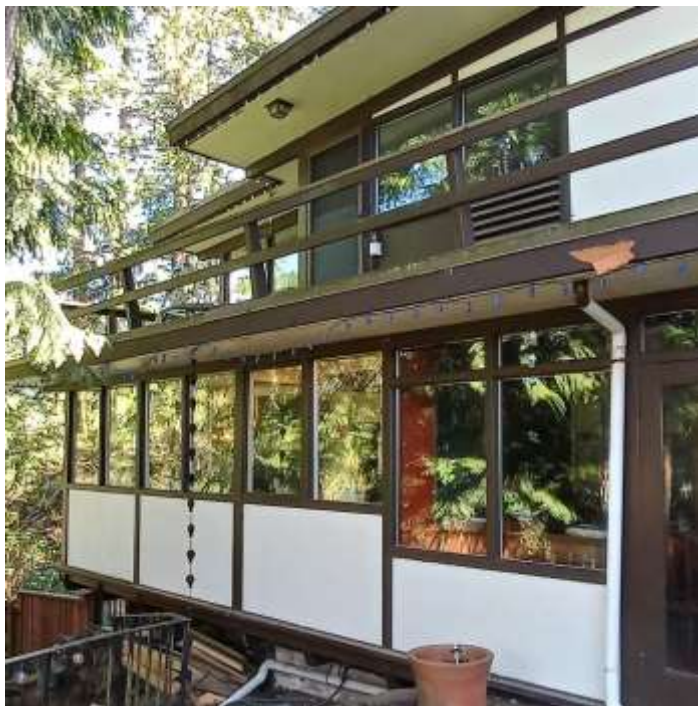
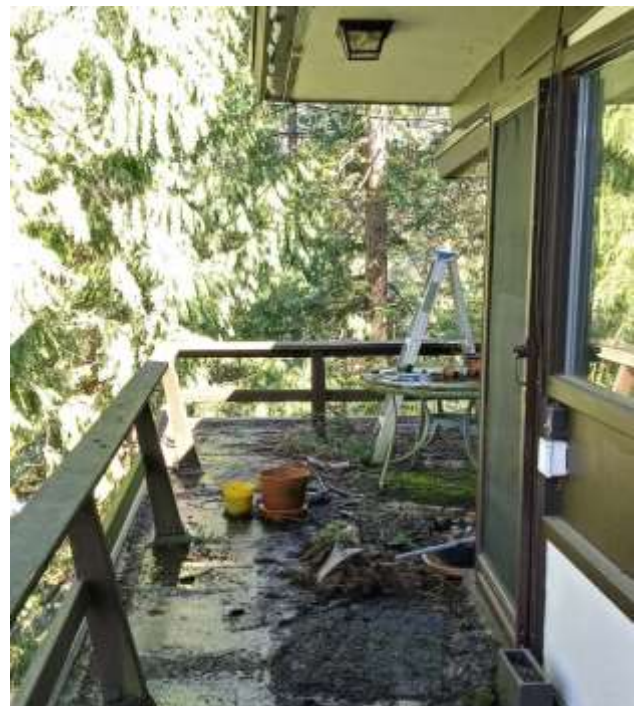
On the north and east side of the house, small portions of the main floor roofs are accessible from the two secondary bedrooms as well as the hall. A precarious wooden railing runs along the edge of the roof overhang. The railing is slanted toward the outside with a wide top plate and one horizontal board, thus exemplifying a typical minimalist design of the mid-century modern style, but do not conform to building code requirements. There is no finished surface onto the roofing felt. These roof surfaces are not apparently used frequently and may have been intended for maintenance only.

Figure 101: North side terrace

Figure 102: Second floor balcony

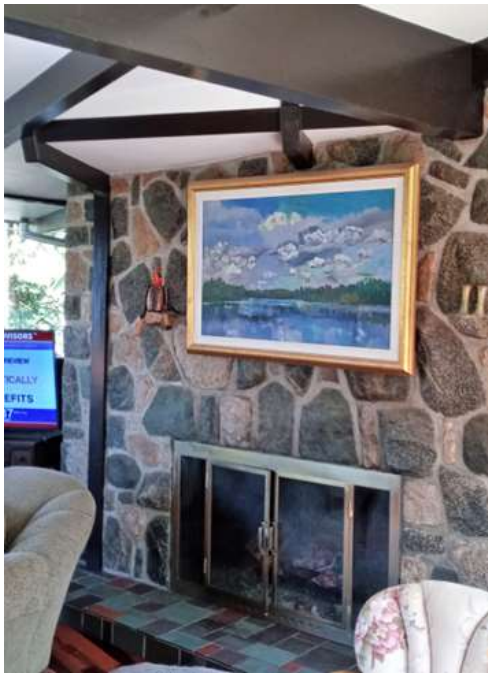
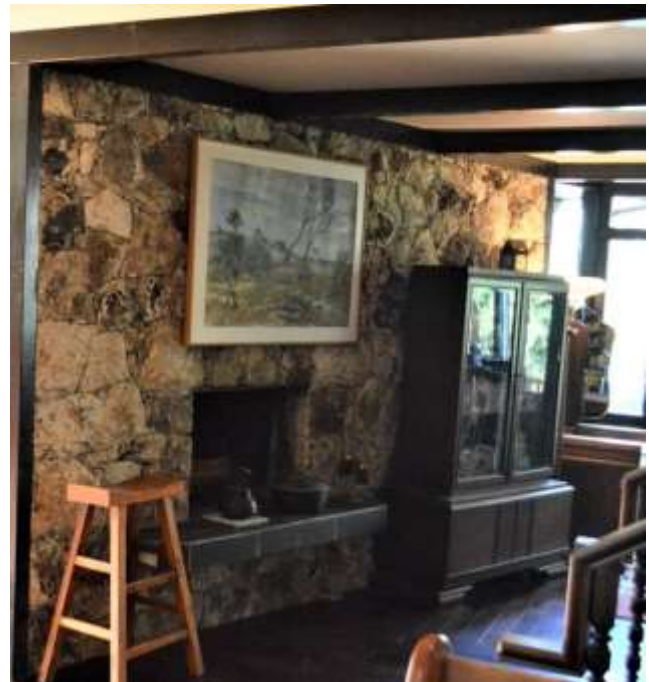
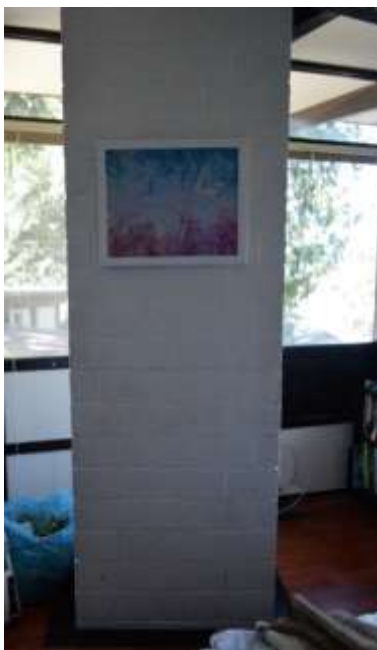
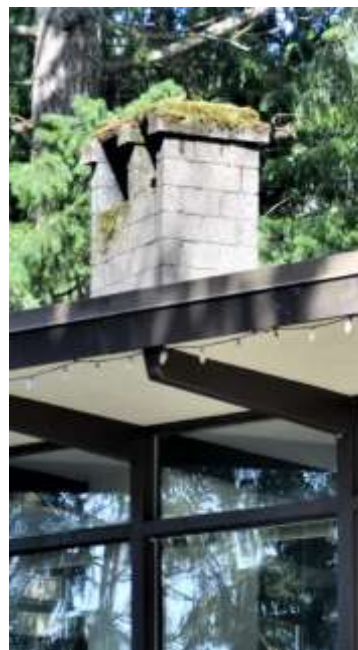
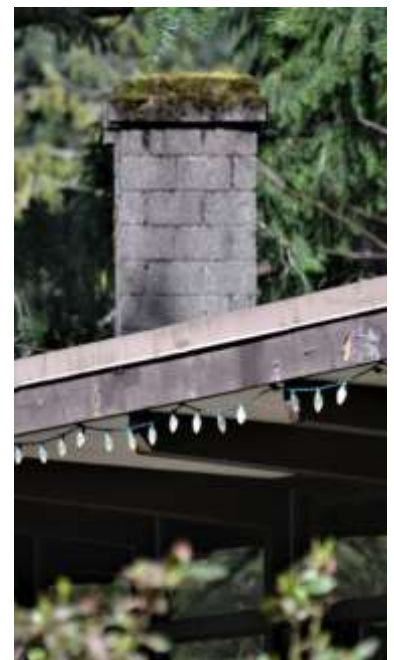
The random field stone clad fireplace stands between the living room and the dining room, with separate hearths facing both rooms. A bookshelf was added on one side of the masonry fireplace. The masonry monolith is set at an angle of its own, neither corresponding to the orientation of the living room walls nor the dining room walls. This peculiar angle of the chimney shaft is carried through the house, the second floor bedroom and above the roof. The exposed chimney shaft is made of concrete blocks; the side exhaust openings are located on the southwest and northeast faces of the chimney. The fireplace masonry is in good condition but the exposed concrete block chimney in fair condition.

Figure 103: Living Room fireplace facing the deck

Figure 104: Living Room fireplace facing the Dining room

Figure 105: Chimney shaft through bedroom

Figure 106: Chimney shaft facing south

Figure 107: Chimney shaft facing east

16. **Internal brick chimney; Rehabilitation:** The main fireplace between the living room and the dining room should be preserved, including its skewed orientation. Consider maintaining concrete block surfaces since the “brutalism” is a hallmark of the period. The chimney shaft through the house should be maintained and free-standing, as currently existing. The exterior chimney exposed above the roof should be rehabilitated; damaged concrete blocks should be replaced with matching material, in kind, size and profile. The design of the chimney cap should be maintained. If the fireplace is to be operational, the height of the exposed shaft above the roof should conform to current standards, without altering the design of the existing chimney cap.

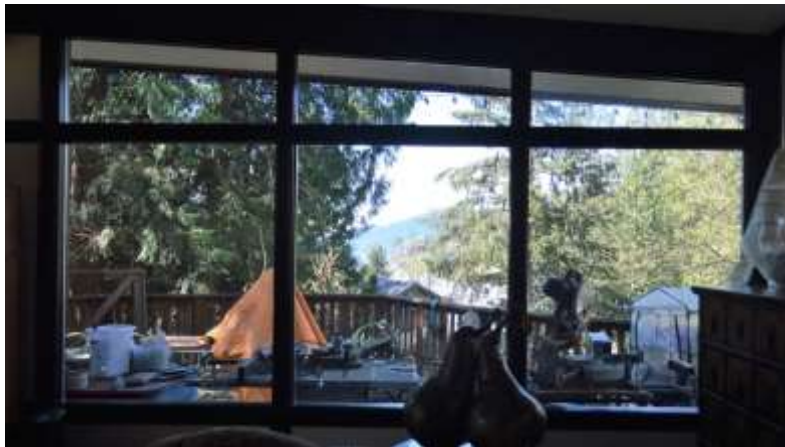
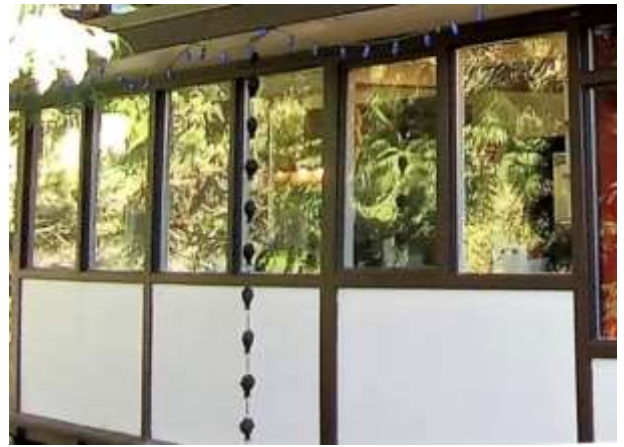
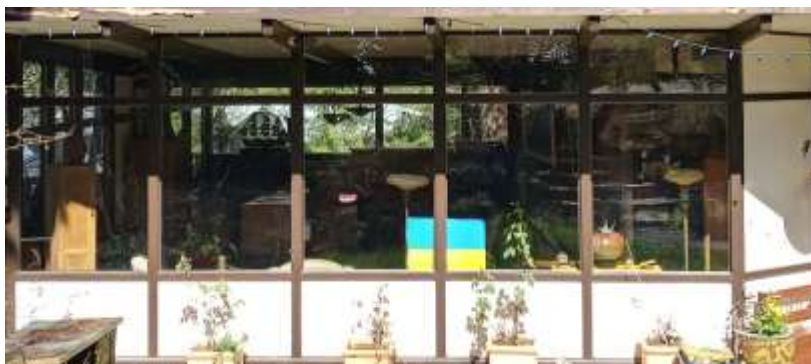
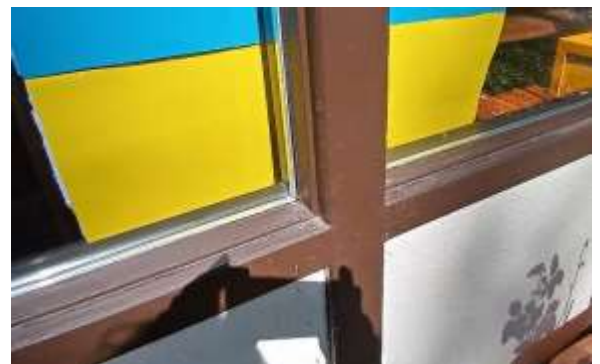
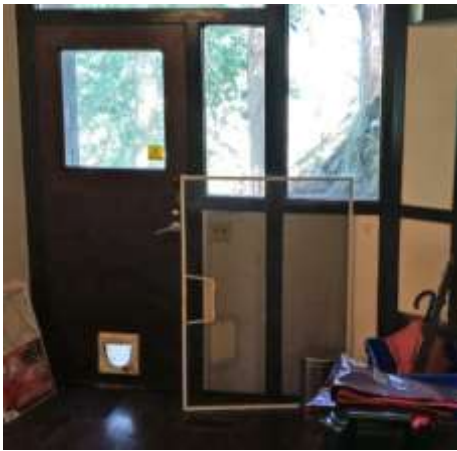
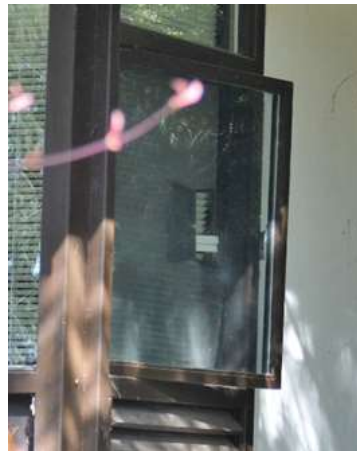
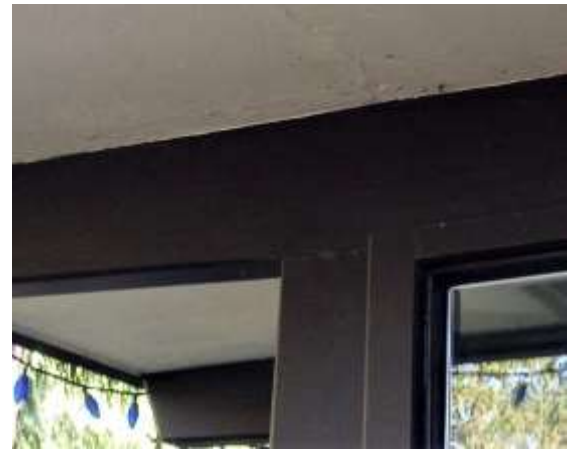
Most of the windows at the Stewart-Lough House are fixed with double glazed with sealed units. Casement windows are strategically located for cross ventilation. The top of windows are generally lining up leaving the transom lites to mediate the slope of the roof. The windows are framed with posts and rails; there are minimum sills and no casing, inside or outside. The windows are in good condition throughout the house.

Figure 115: West side windows with transom WW 01 – WW 06

Figure 116: Living Room windows with transom WW 01 – WW 03

Figure 117: Kitchen and Breakfast windows WN 05 - 13

Figure 118: Living Room fixed windows WS 01 - 05

Figure 119: WS 03 – 04 Fixed window sill

Figure 120: Storage door and window WE 03 -04

Figure 121: Casement opening

Figure 122: Fixed window head WS 01

14. **Windows; Preservation/rehabilitation:** Windows and transom lites should be reviewed by a qualified window specialist. Leaking sealed units should be replaced and replacement installed in the same manner as existing. Window sill, and casings should remain the same as existing. The location and number of casement windows should be maintained. Casement windows should be reviewed and their smooth operation rehabilitated if required. Window frames should be refinished where needed, matching existing lustre and colour.

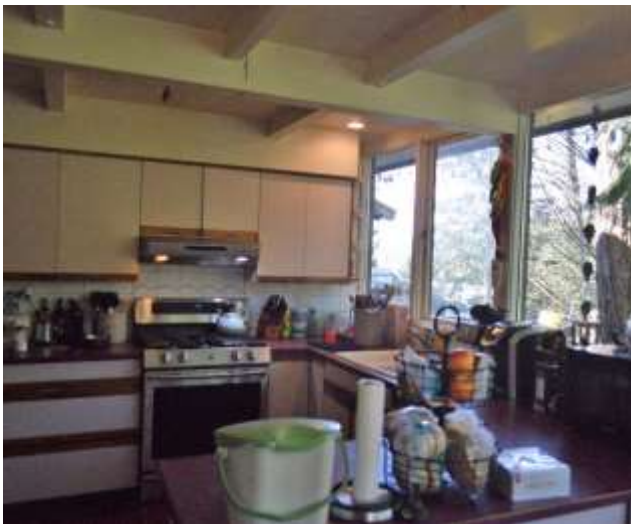
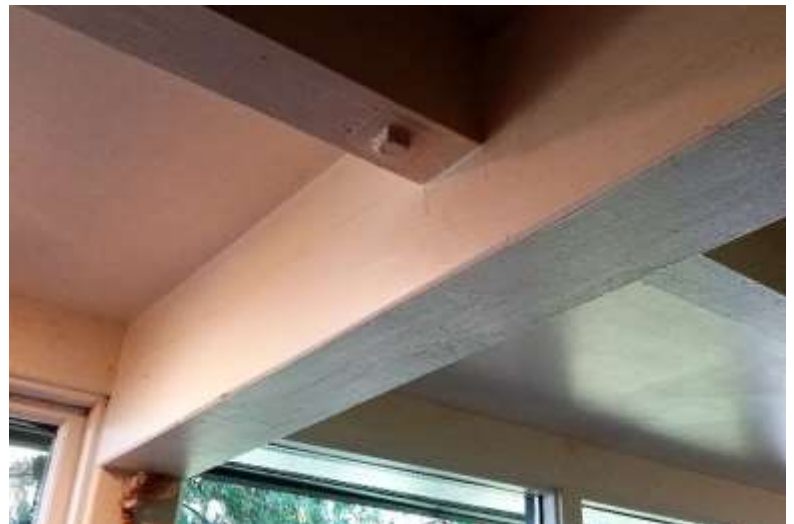
Figure 123: Kitchen structure painted white

Figure 124: Steel structural member reinforcing the kitchen ceiling
