northwest hydraulic consultants

Subject: 4701 Piccadilly Place South - Creek Realignment
Hydrology and Hydraulic Design – Updated for Revision 2 Drawing

Northwest Hydraulic Consultants Ltd. (NHC) is pleased to present this technical report which outlines the design for the realignment of an ephemeral¹ watercourse at 4701 Piccadilly Place South in the District of West Vancouver (DWV).

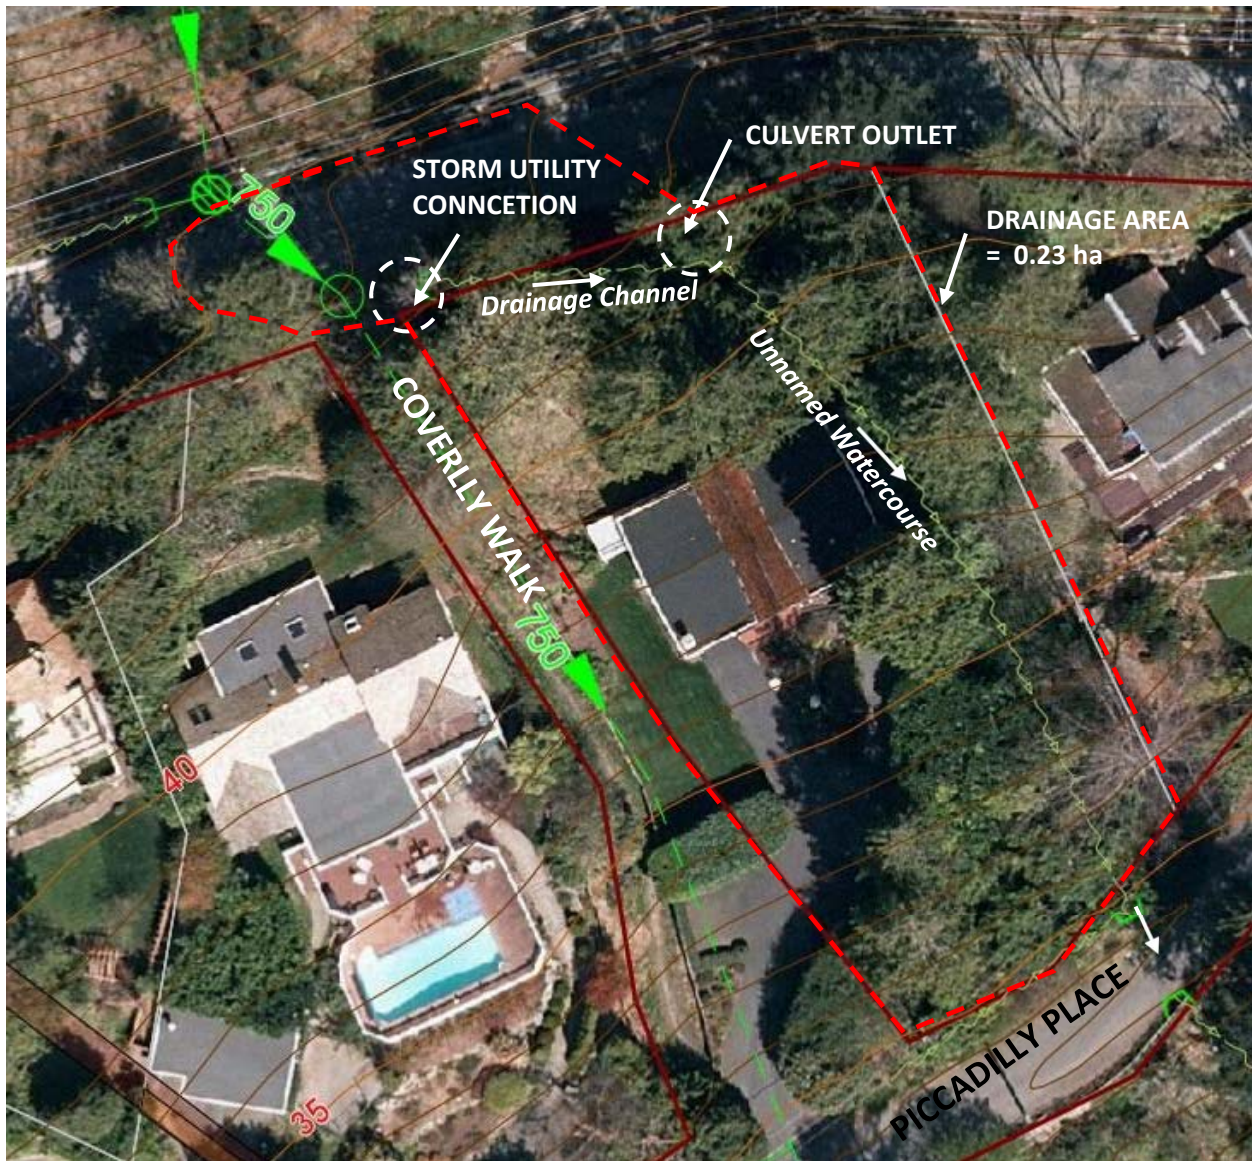
Figure 1. Project Overview and Drainage Area (drainage network and orthophoto from DWV GIS).

The property is bounded by Marine Drive to the north and Piccadilly Drive to the south. The DWV right of way, containing Clovelley Walk and a subsurface storm utility, bound the property on its west side and the residential property of 4699 Piccadilly bound the property to the east. An unnamed watercourse bisects the property from north to south (**Figure 1**).

The watercourse originates at the northeast end of the property at the outlet of a corrugated metal pipe under Marine Drive (**Figure 1** and **Photo 1**). During the site visit in December the culvert was dry, despite intense precipitation the previous 4 days; as stated in **Table 1** for the Environment Canada West Vancouver gauge (1108824). Upstream property and road drainage appears to be directed to other systems such as the DWV storm system under Clovelley Walk.

In addition, a small drainage channel, which was likely constructed by previous owners, runs west to east along the north boundary of the property (**Figure 1** and **Photo 2**). Regular flow to the drainage channels appears to have previously been provided by a piped and valve controlled connection from the DWV storm utility (now sealed) (**Photo 3**). The drainage channel currently only intercepts seepage and overflow from Marine Drive and directs it to the unnamed watercourse 4 m downstream of the northern

The drainage area for the channel is conservatively estimated as 0.23 ha which was determined from field investigation and site survey and is shown on **Figure 1**.

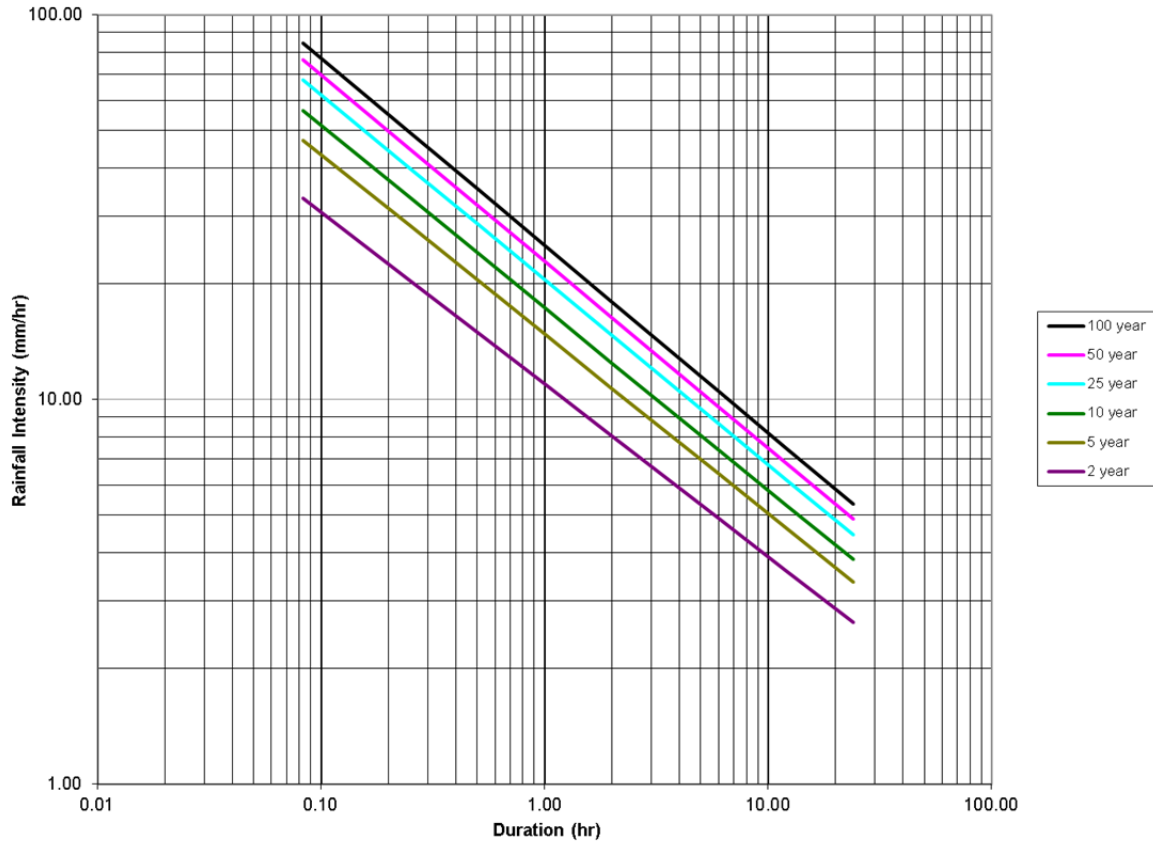
Figure 2. Metro Vancouver West Vancouver Firehall Rainfall Gauge (WV 49) IDF Curve (provided by Metro Vancouver).

The Metro Vancouver (MV) rain gauge at the West Vancouver Firehall (VW 49) (**Figure 2**) was used to estimate precipitation at the site due to its proximity to the site. The station contained data for the period of 1995 to 2012, thus providing 18 years of record. The IDF curve was used un-altered for the site and was provided by Metro Vancouver for use in this study.

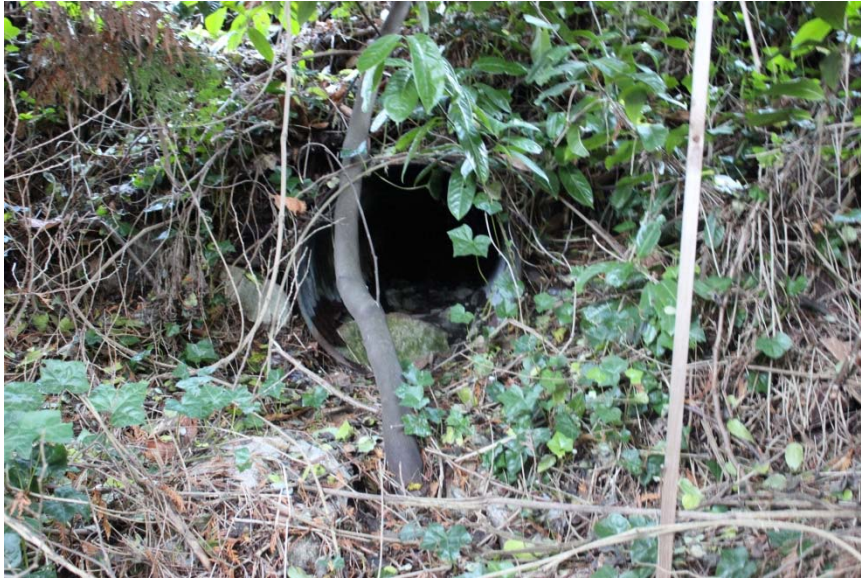
Photo 1. Unnamed watercourse originates at culvert outlet on property at Marine Drive. View looking upstream (North) towards Marine Drive.

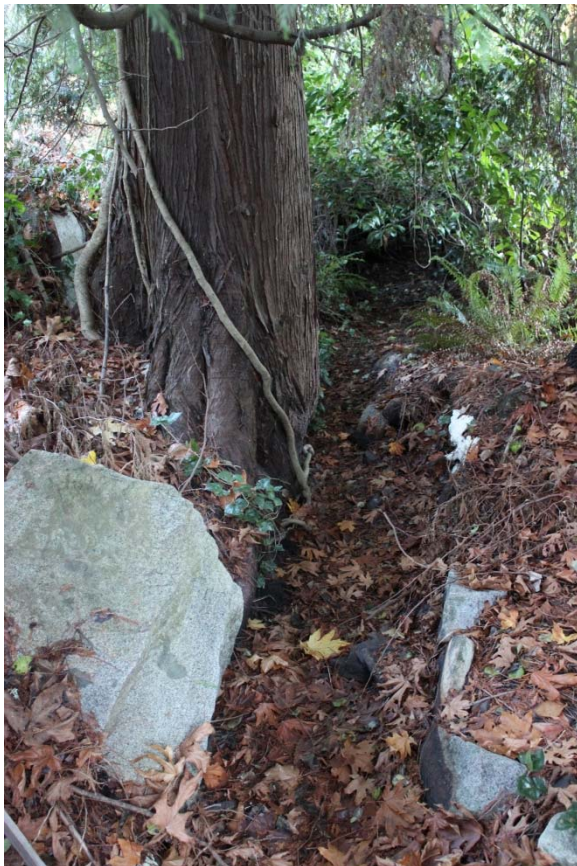
Photo 2. Manmade drainage channel running west to east along north boundary of property. View looking upstream (west).

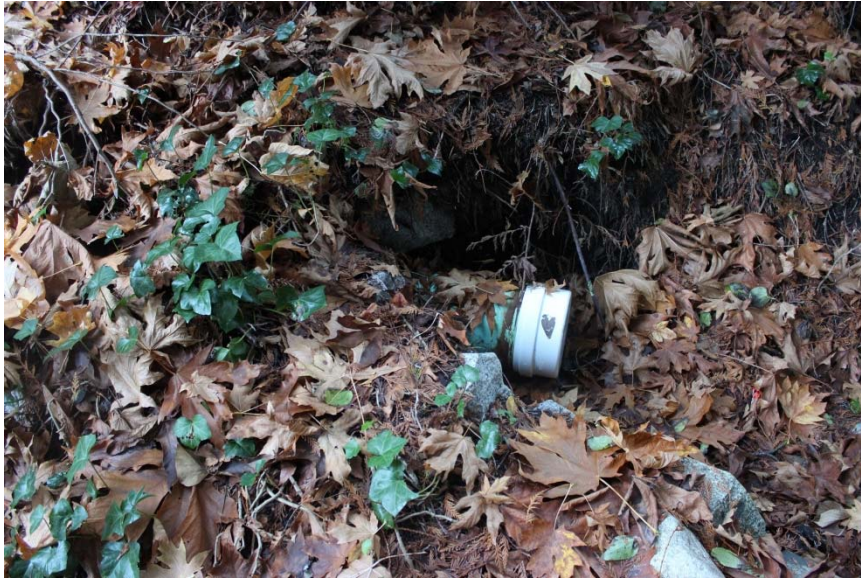
Photo 3. Sealed connection at drainage channel to DWV storm water utility.

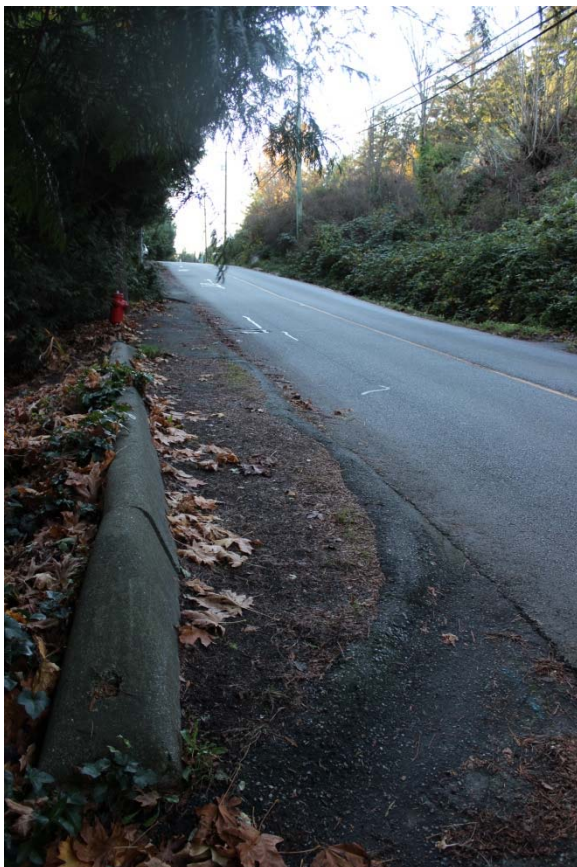
Photo 4. Road drainage from Marine Drive directed to drainage channel. View looking west on Marine Drive.

property boundary (**Photo 4**). Similar to the unnamed watercourse, the drainage channel is expected to only convey flow during the most extreme events.

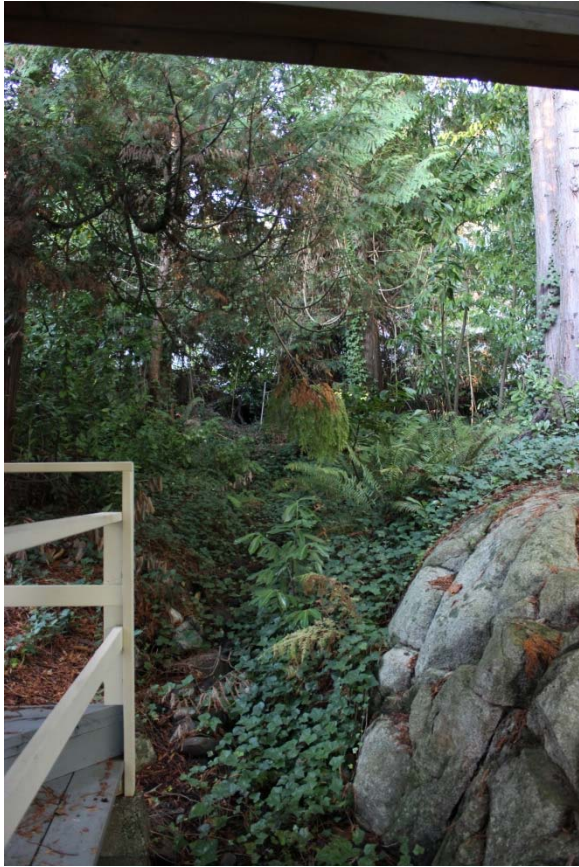
Photo 5. Unnamed watercourse in backyard of existing structure, prior to flowing into concrete lined channel under deck. View looking upstream.

The following 14.5 m downstream of the confluence with the drainage channel, the watercourse runs through a vegetated area with well-defined banks (**Photo 5**). After which there is an 8.5 m long concrete lined channel under the deck of the existing house (**Photo 6**). The watercourse then outlets to an approximately 9 m long by 3 m wide and 0.5-1.0 m deep man-made pond where water level is controlled by a concrete weir at the ponds outlet (**Photo 7**). The pond outlets through a small 22 m long grass lined ditch to a rock outcrop (approximately 2.3 m from the properties south boundary), where flow spills over without a defined channel or path (**Photo 8**). At the base of the rock, surface flow is collected by

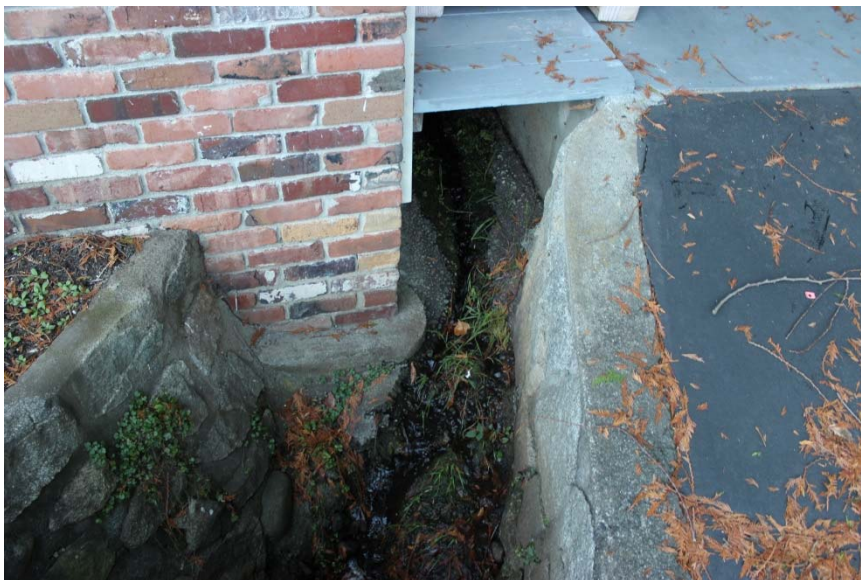
Photo 6. Outlet of concrete lined channel under existing deck. View looking upstream towards existing structure.

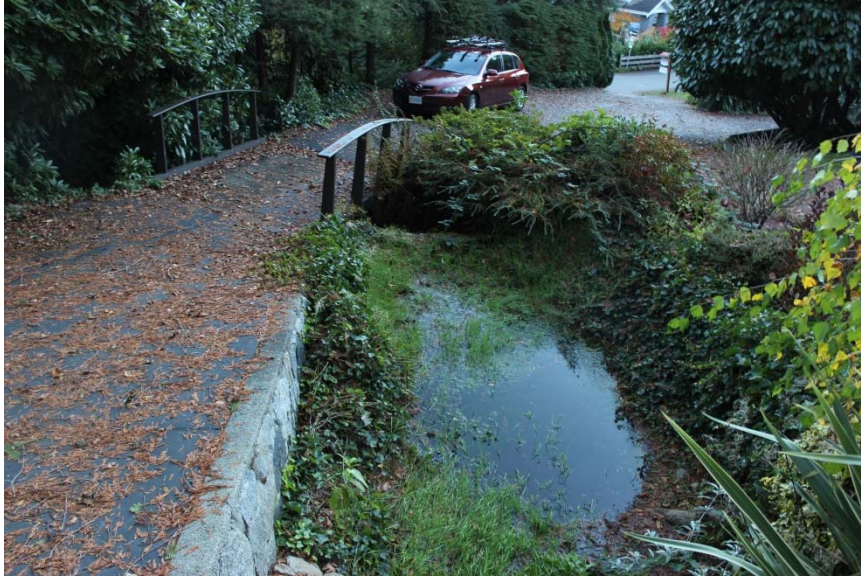
Photo 7. Manmade pond with concrete weir at wood bridge. Limited riparian area at rock wall/asphalt drive. View looking downstream towards Piccadilly Drive.

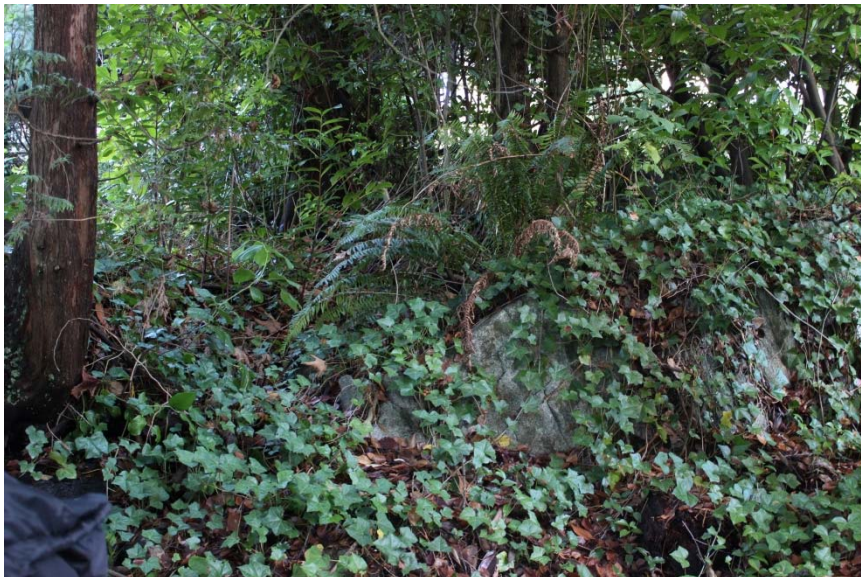
Photo 8. Undefined drainage path at rock outcrop near south east corner of property. View looking upstream towards pond outlet.

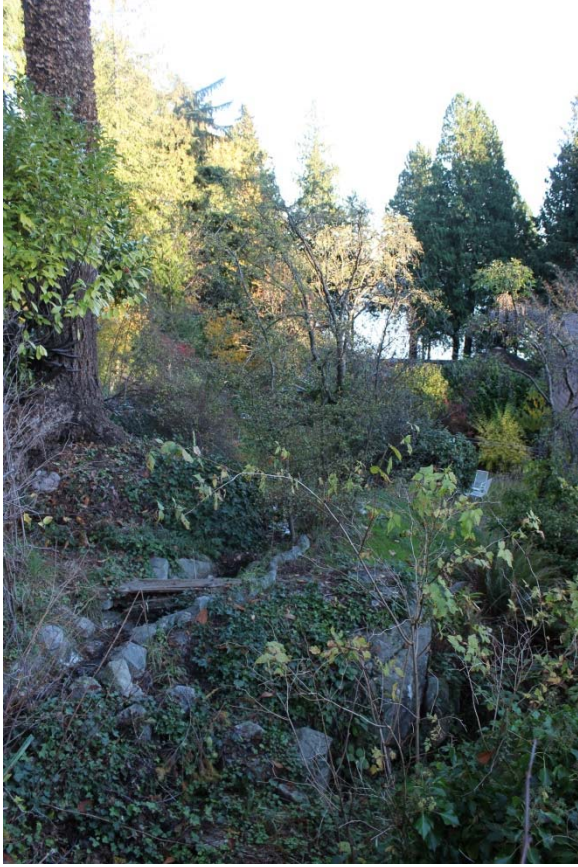
Photo 9. Rock lined channel along 4704 Dogwood Lane. View looking downstream towards Burrard Inlet.

the road drainage ditch and directed through a culvert under Piccadilly Place South. Flow then continues south in an approximately 0.6m wide by 0.3 m deep rock lined channel along 4704 Dogwood Lane (**Photo 9**) prior to discharging to Dogwood Creek and subsequently Burrard Inlet.
