COUNCIL REPORT

Date:	March 31, 2025
From:	Sean O'Sullivan, Senior Manager Roads & Transportation Planning, Design & Projects
Subject:	Glenmore Neighbourhood Traffic Calming
File:	09.1700

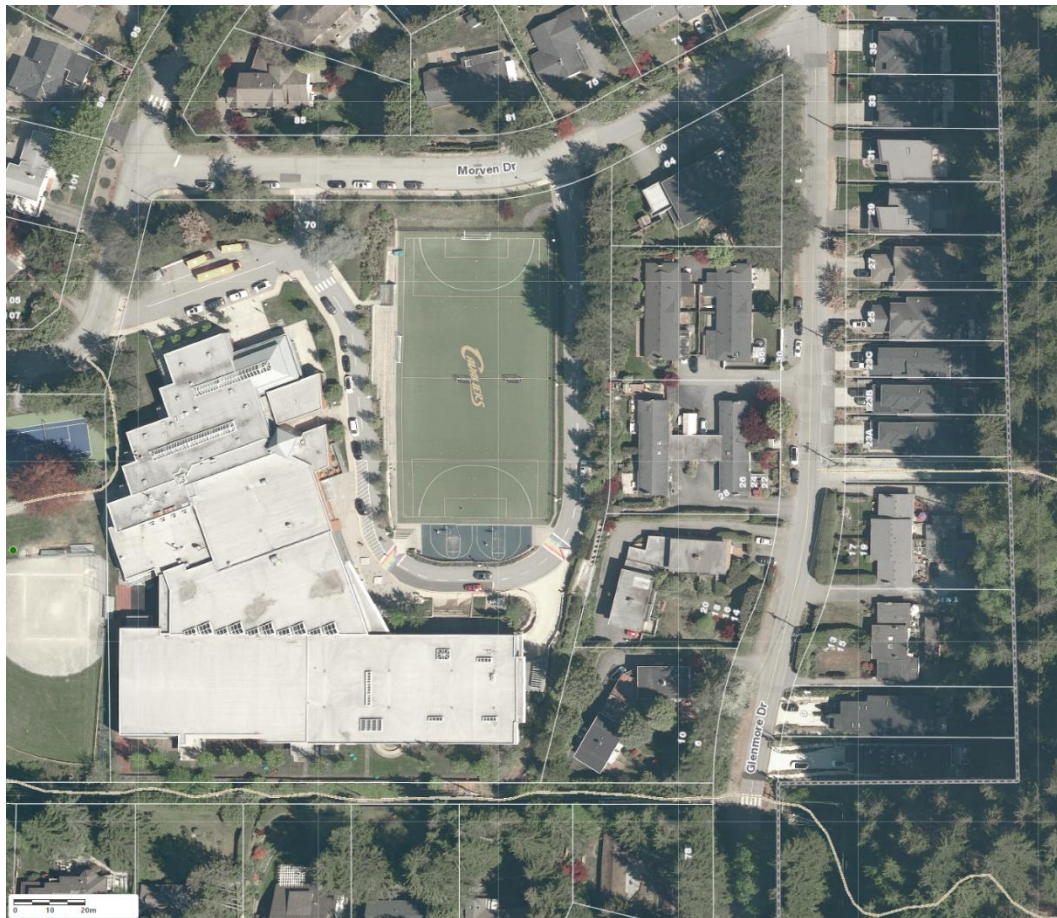
Description - Glenmore Drive between Morven Drive and Baden Powell Trail is a low volume residential local road that is approximately 7 m wide and slopes approximately 3% to the south, **Figure 1**. The north half of the roadway is straight, and the south half has a slight curve. On the east side, there is a gravel and paved boulevard along the north half of the road and along the south half there is a narrower gravel and paved boulevard with vegetation and landscaping encroachments. On the west side there is a wide gravel and paved boulevard with mature vegetation and landscaping encroachments.

Figure 1 - Aerial Map of Glenmore Drive and Collingwood School – Morven Campus.

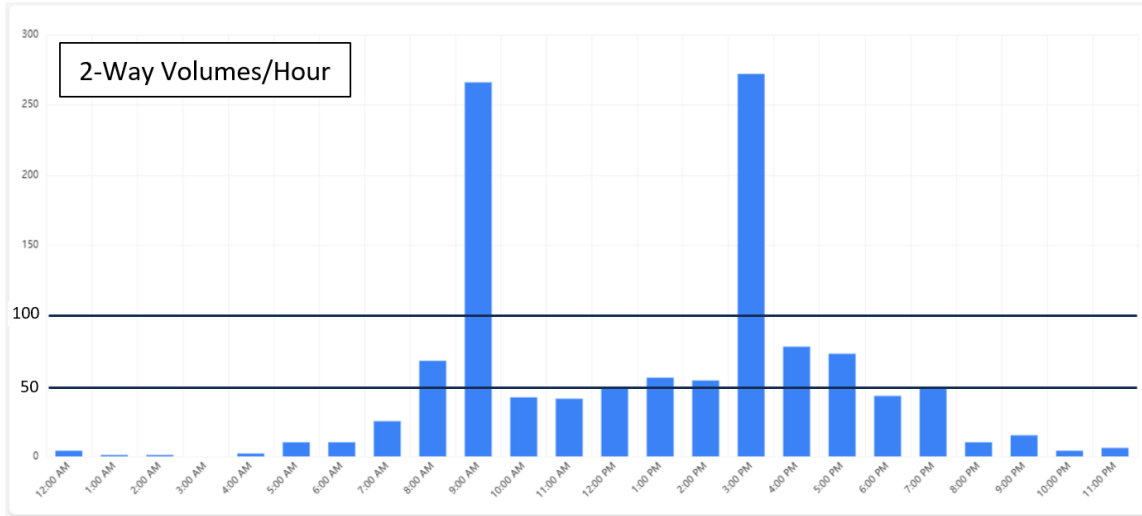
Traffic Volumes - Glenmore Drive is one of two primary routes to Collingwood School – Morven Campus. During drop off and pick up times traffic volumes peak at about 270 vehicles/hour, **Figure 2**. Outside the pickup and drop off times, the average daytime traffic volume is 55 vehicles/hour. During the week, the total traffic volume average is 1,155 vehicles per day and on the weekend the average is 467 vehicles per day.

Figure 2 - Glenmore Drive 2-way Traffic Volume per Hour on Wednesday May 29, 2024.
