Date: September 12, 2013 File: 1010-20-12-084  
From: Lisa Berg, Senior Community Planner  
Subject: **Official Community Plan Amendment, Rezoning and Development Permit No. 12-084 for 825 Taylor Way and 707 Keith Road (Maison Seniors' Living)**

# MAISON SENIOR LIVING RESIDENCE

## DESIGN BRIEF - RATIONALE FOR PROPOSED DEVELOPMENT

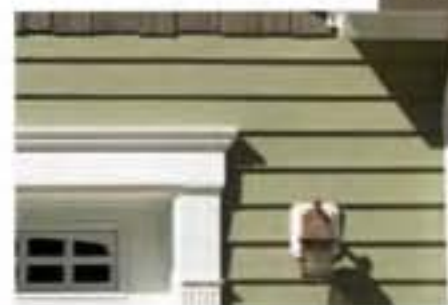
**CEMENT SIDING  
HARDIE**

- WOODSTOCK BROWN
- CHESTNUT BROWN
- TIMBER BARK

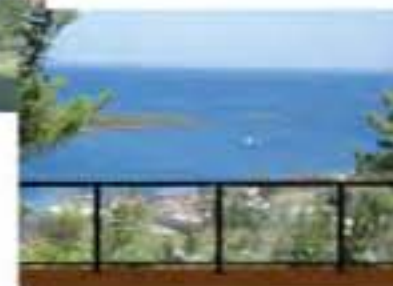
**GLASS FEATURES**

CURTAIN WALL GLAZING  
SYSTEM WITH CLEAR  
DOUBLE GLAZING

CLEAR TEMPERED  
BALCONY GLAZING

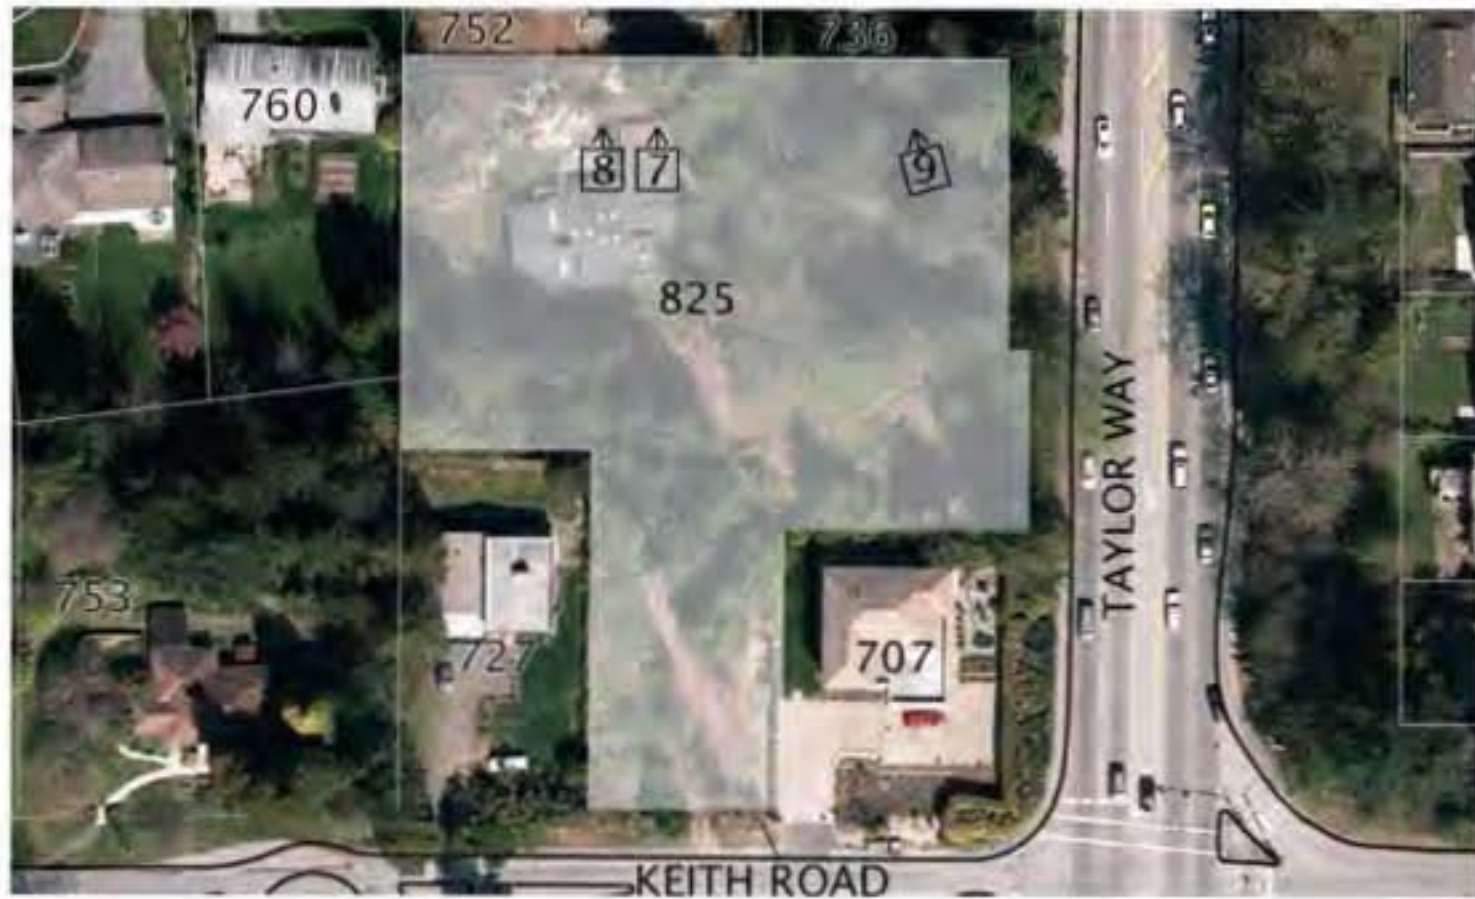
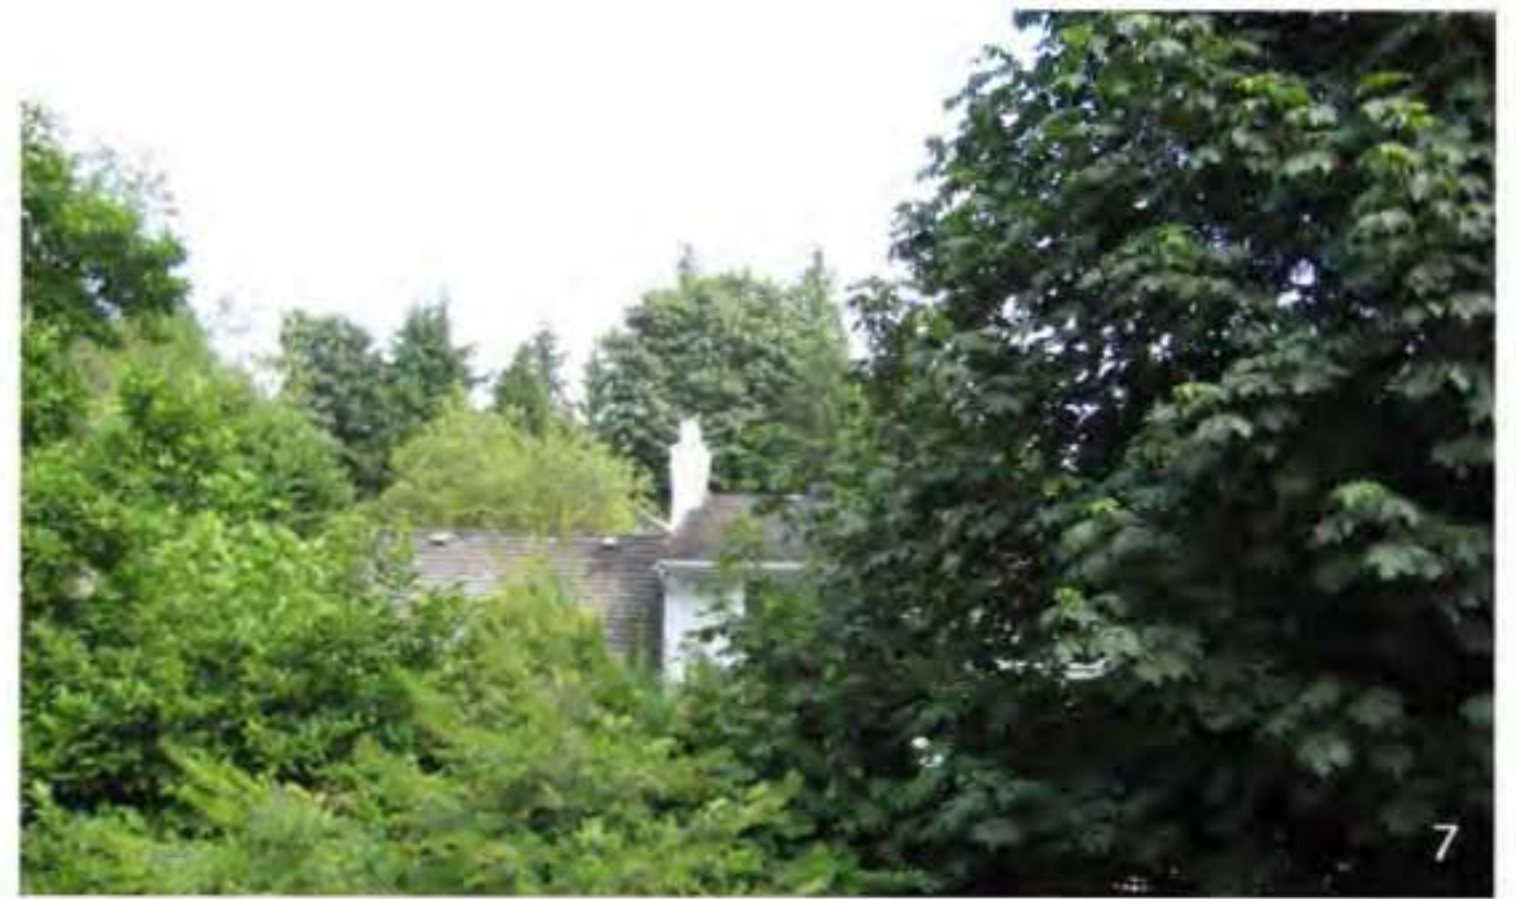
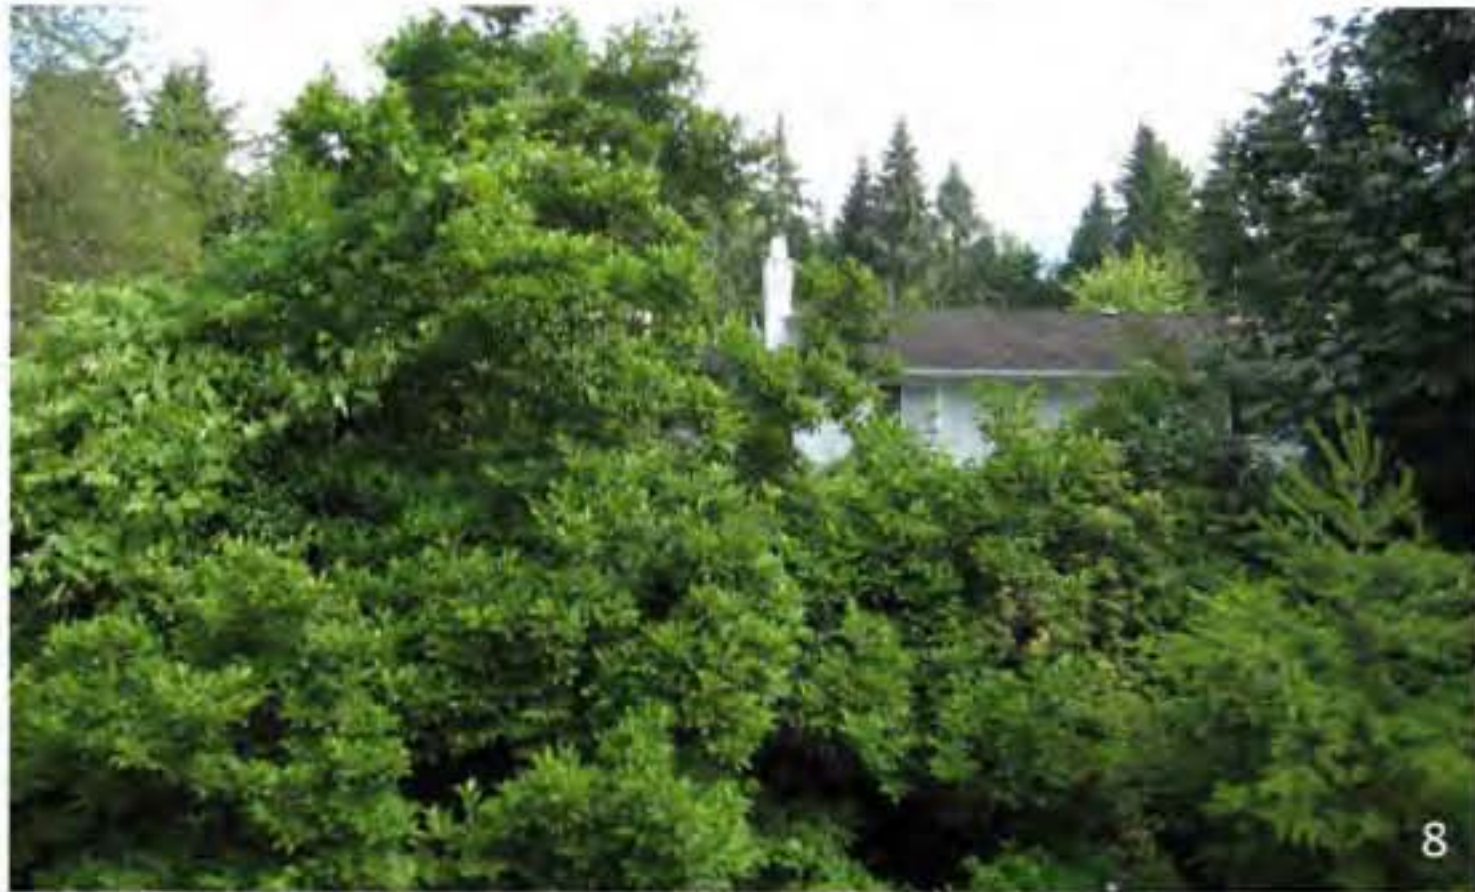
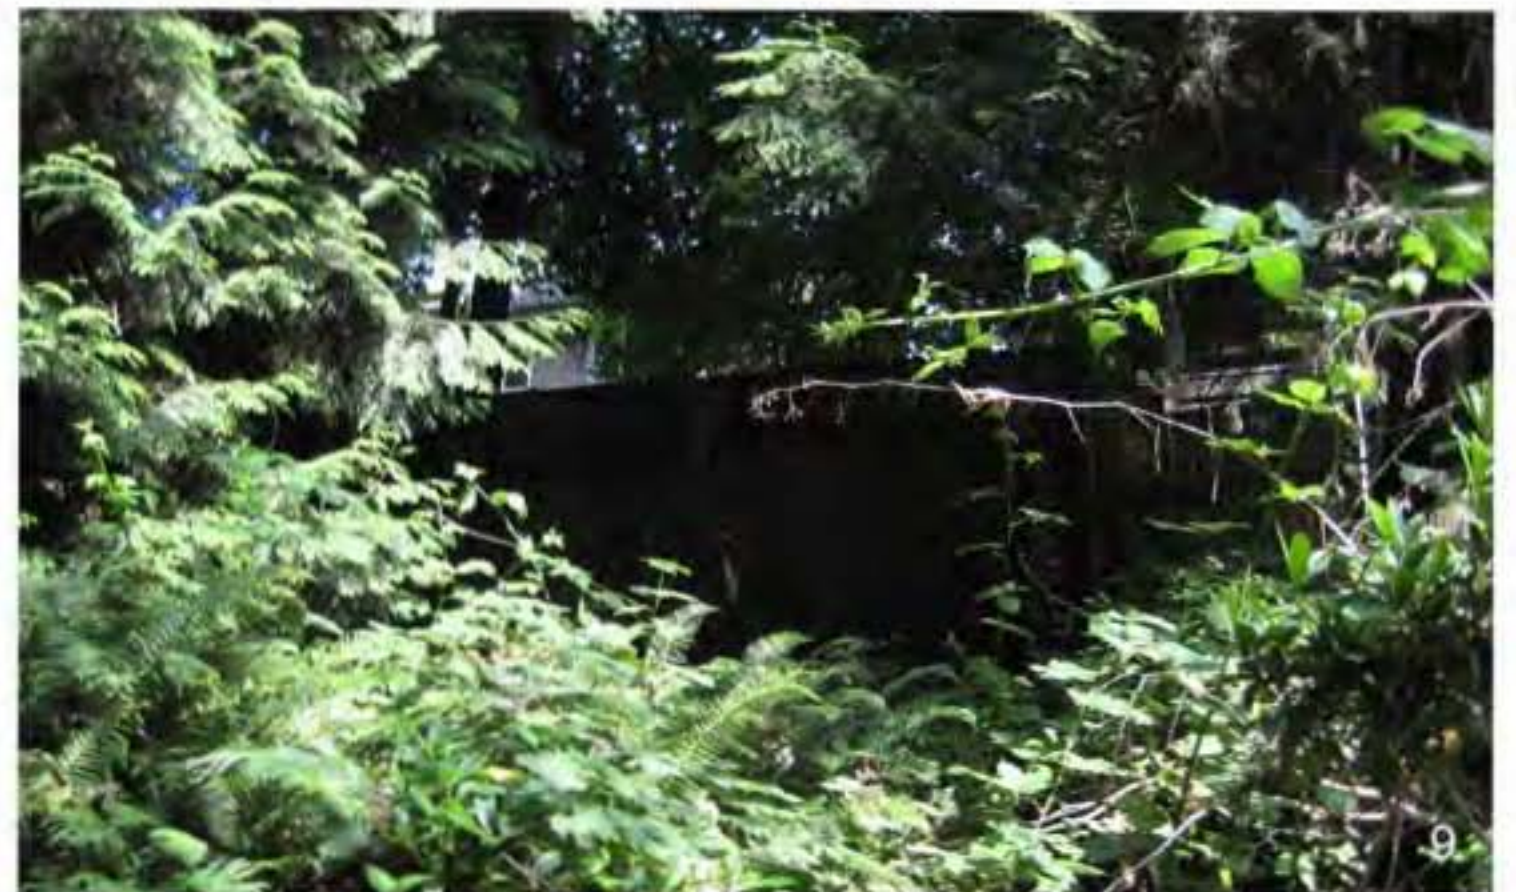
## SITE PHOTOS

Note: Access to surrounding properties to photograph views looking into the site has not been approved by property owners

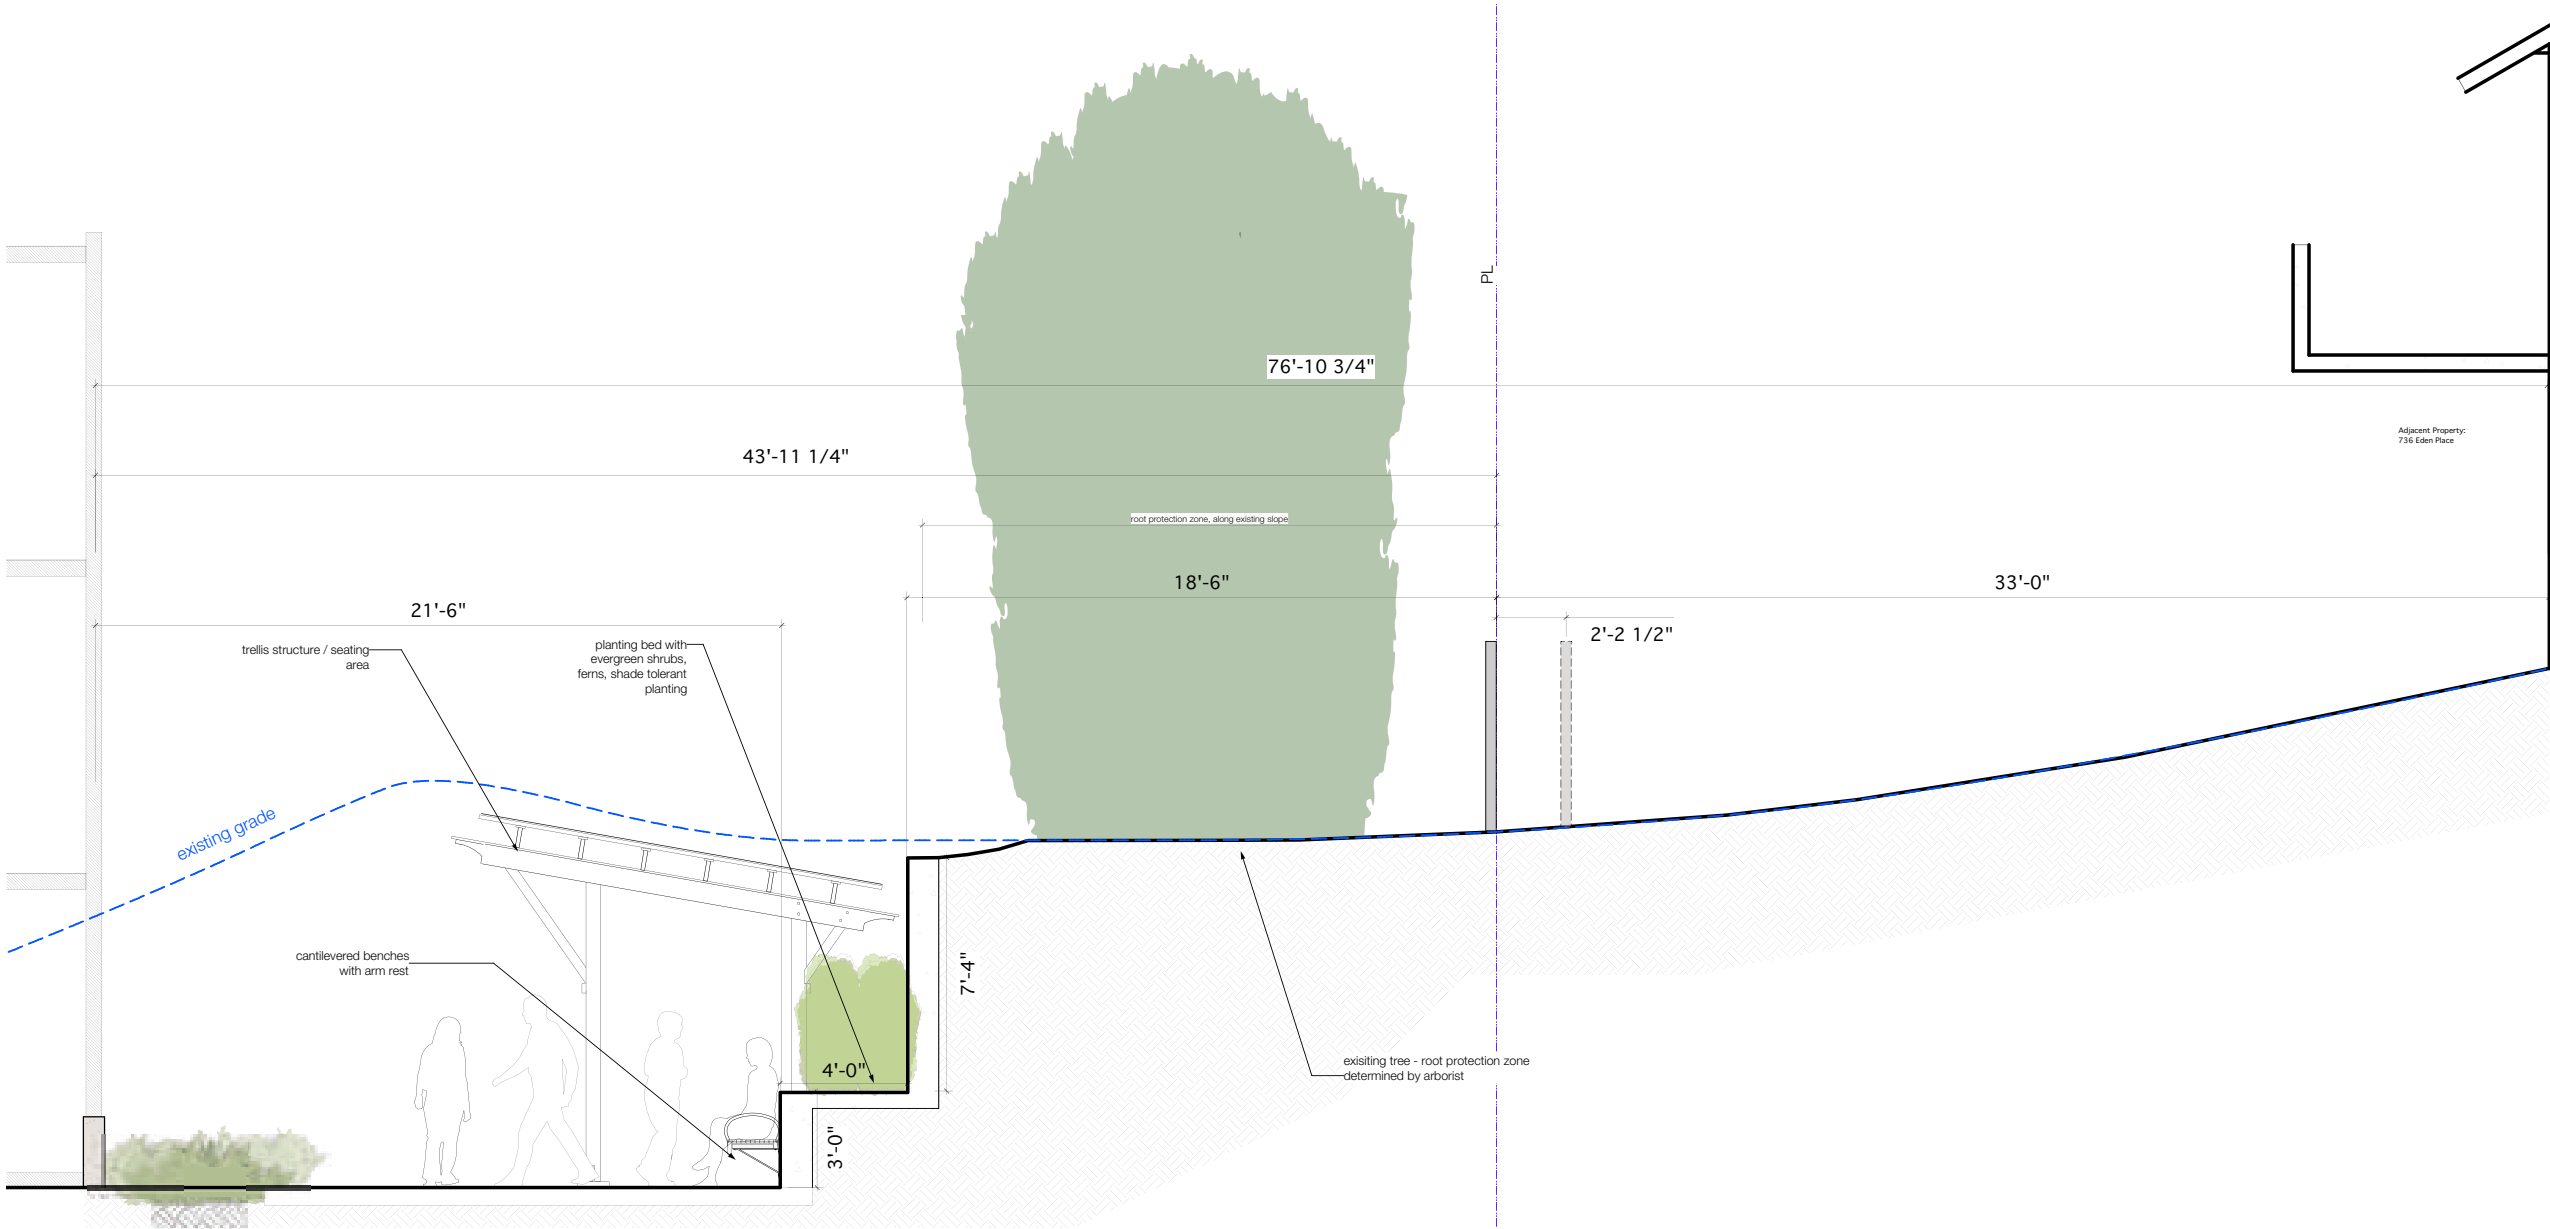
1 Section  
Scale: 1/2" = 1'-0"

Project Manager GE	Project ID 21249
Drawn By	Scale
Reviewed By	Drawing No. <b>L4.2</b>
Date 11/20/12	Sheet 5

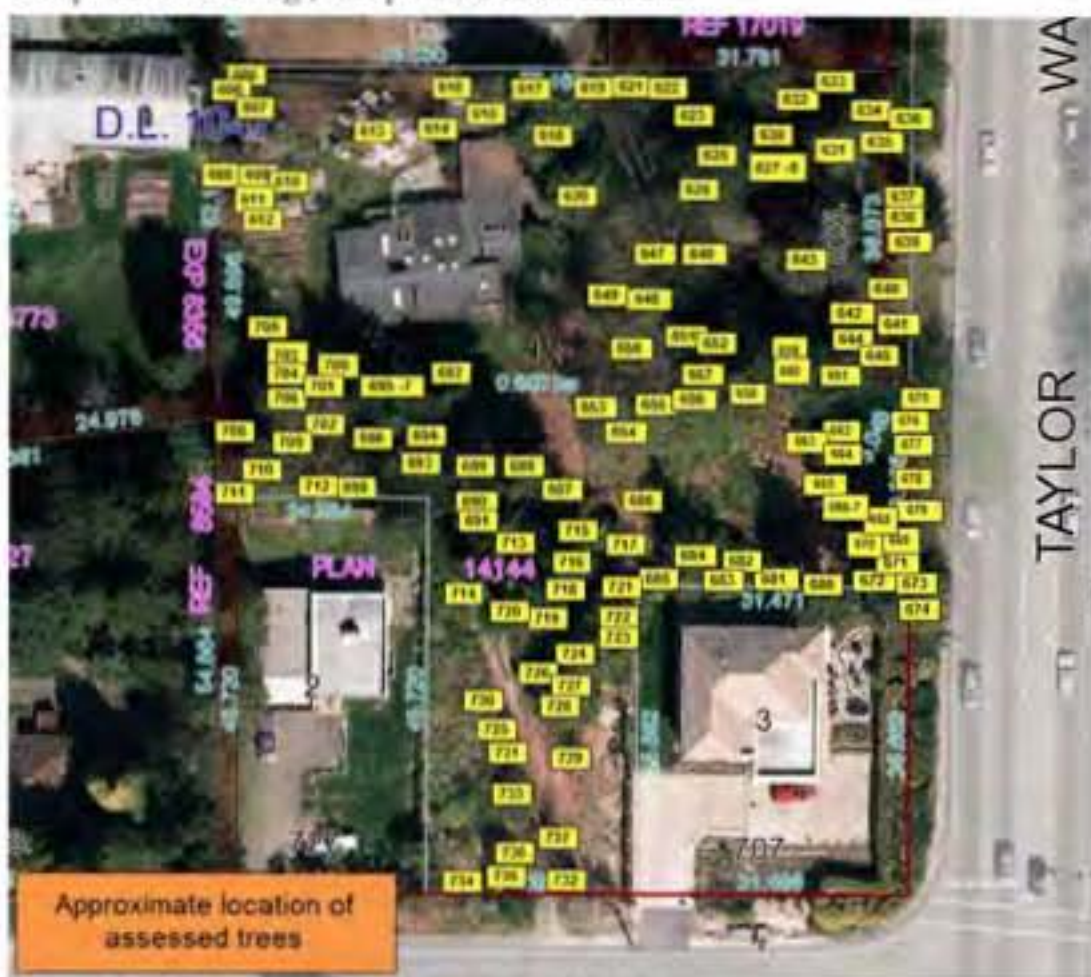
Picture 1. Aerial View of Property showing location of tagged trees

There were no trees on the neighbouring properties that were noted as being within close proximity to the shared property lines or that would be expected to be impacted by the proposed construction work. The majority of the trees that are responsible for screening the properties from one another come from the trees located within the property boundaries of 825 Taylor Way. The tree species have been identified, their heights approximated, their overall condition and any observations are recorded and can be found within the attached

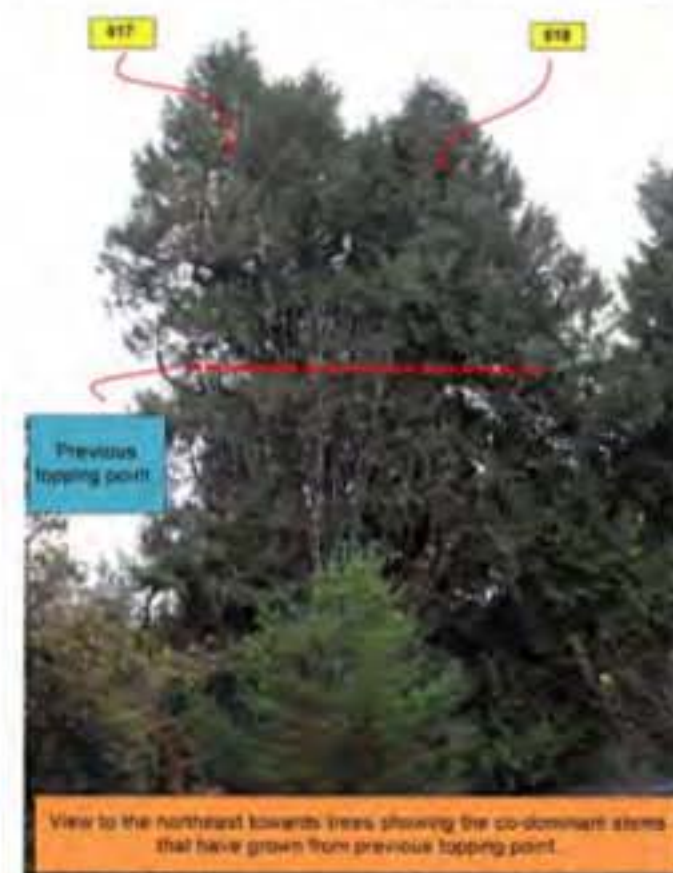
Picture 2. Previous topping

The majority of these trees are located with the property boundaries of 825 Taylor Way and almost all of them have been previously topped at some point in past. This can occur by natural means (breakage by snow load or a bird sitting on a terminal branch) or by mechanical means (cutting the top off which is an antiquated practice) which is more likely the case on this site. The multiple stems that result from the topping generally have weak attachments and are more susceptible to failure at these attachment points. Consequently, trees that are previously topped generally have a high probability of decay within the tree. This also contributes to the high probability of stem failure if the canopy or top of the tree far outweighs what the lower decayed stems can bear. As the trees grow and the shoots increase in weight, the branches of a topped tree become susceptible to breaking off during storms, heavy winds, snow or precipitation loads.

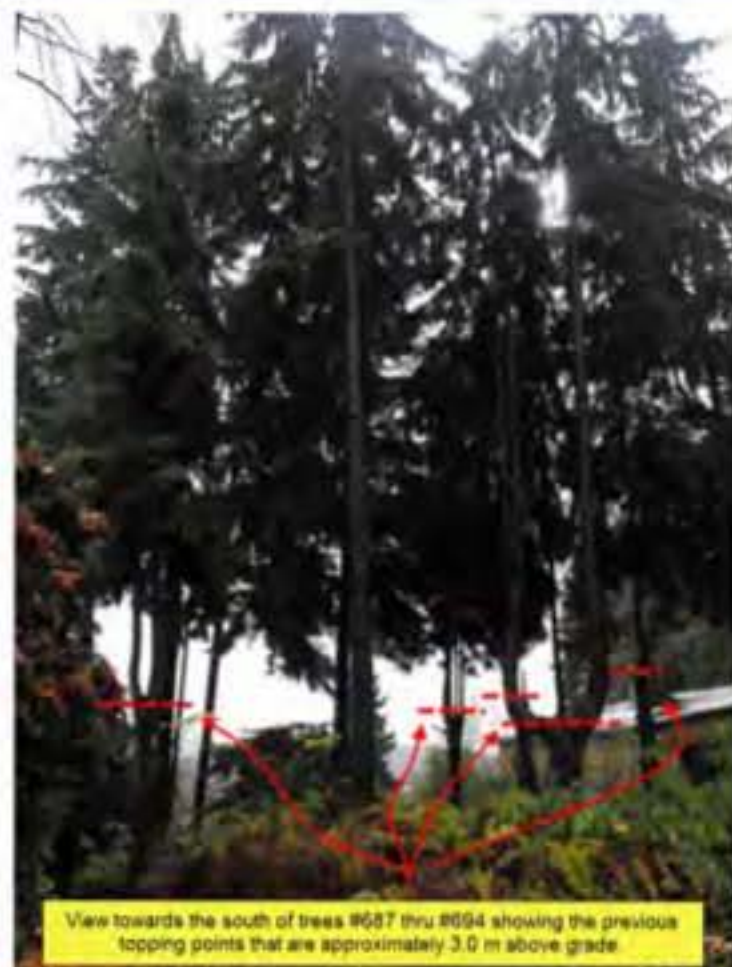
Picture 3. Previous topping

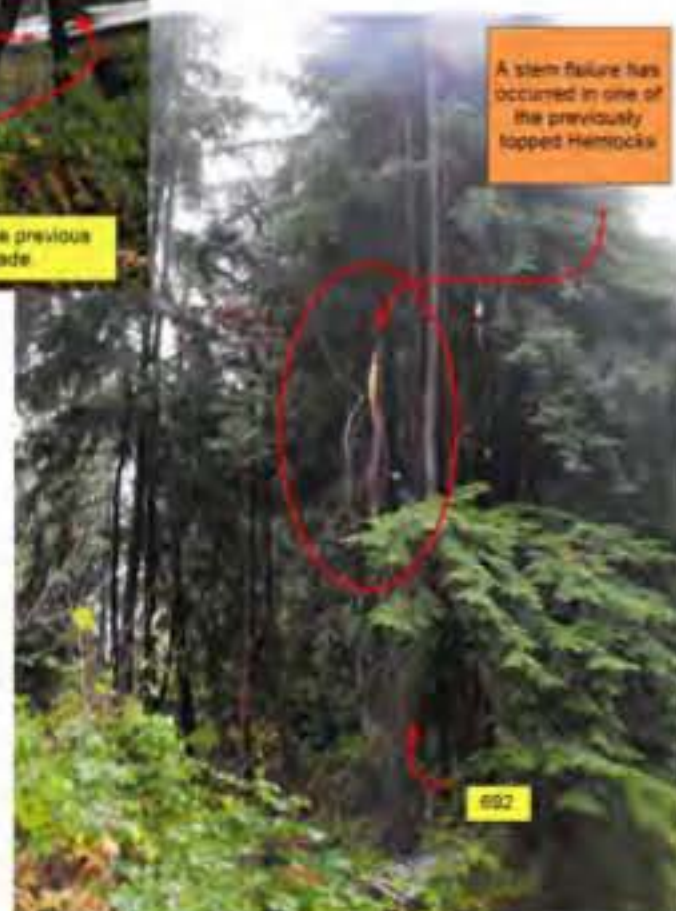
Picture 4. Stem failure in previously topped tree

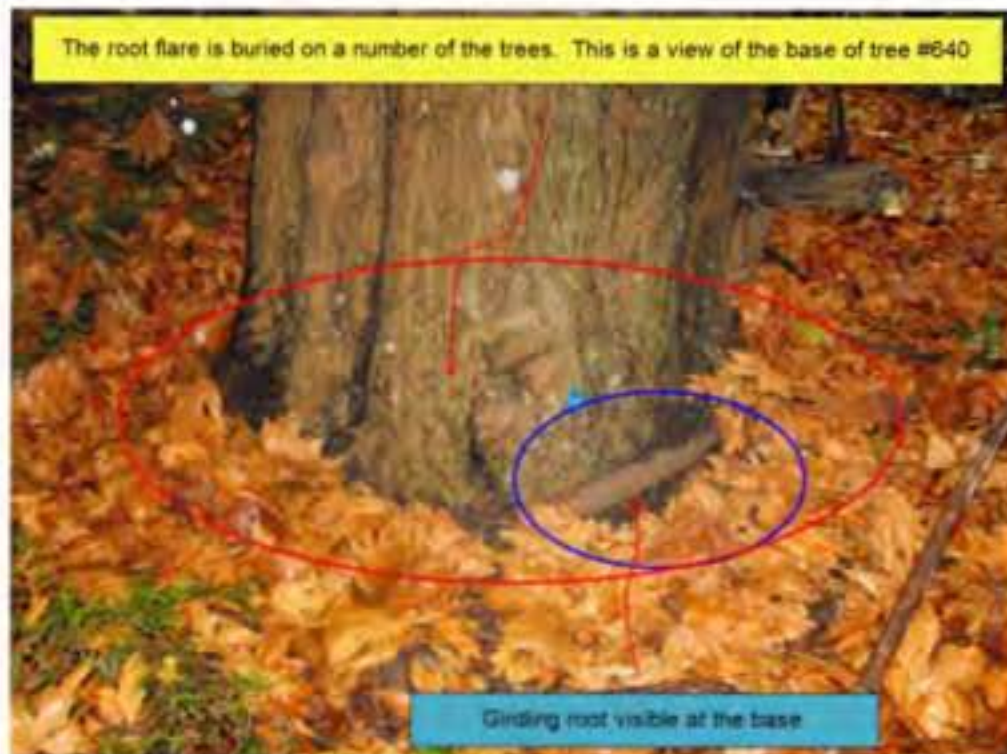
Picture 5. Buried root flares and girdling roots

It was also observed that the root flares are either buried or partially buried on most of these trees. This is likely the result of the natural accumulation on the forest floor over time. There were also many of the trees that had structural roots visible at the surface and a few of them exhibited girdling roots near their bases. Girdling roots grow across or perpendicular to the radial placement of roots. This can pose problems for some trees the more mature they get. They can survive for many years with girdled roots but eventually the girdling will cause 'choking off' of a buttress or structural root causing decline and possible death for the tree. For the most part their buttress roots appear to have developed to compensate for the growing conditions on this site and the varying terrain. Therefore they are considered to have an atypical placement of their roots however the vast majorities appear to have adapted well. There was one tree noted as having experienced a partial root failure as a result of growing on a rock or nurse log where either there was insufficient soil for root anchorage or natural decay of the nurse log caused the tree to go over. It does not pose a high risk at this time as it remains a juvenile however it is not likely to be a long term landscape investment on this site the more mature it gets.

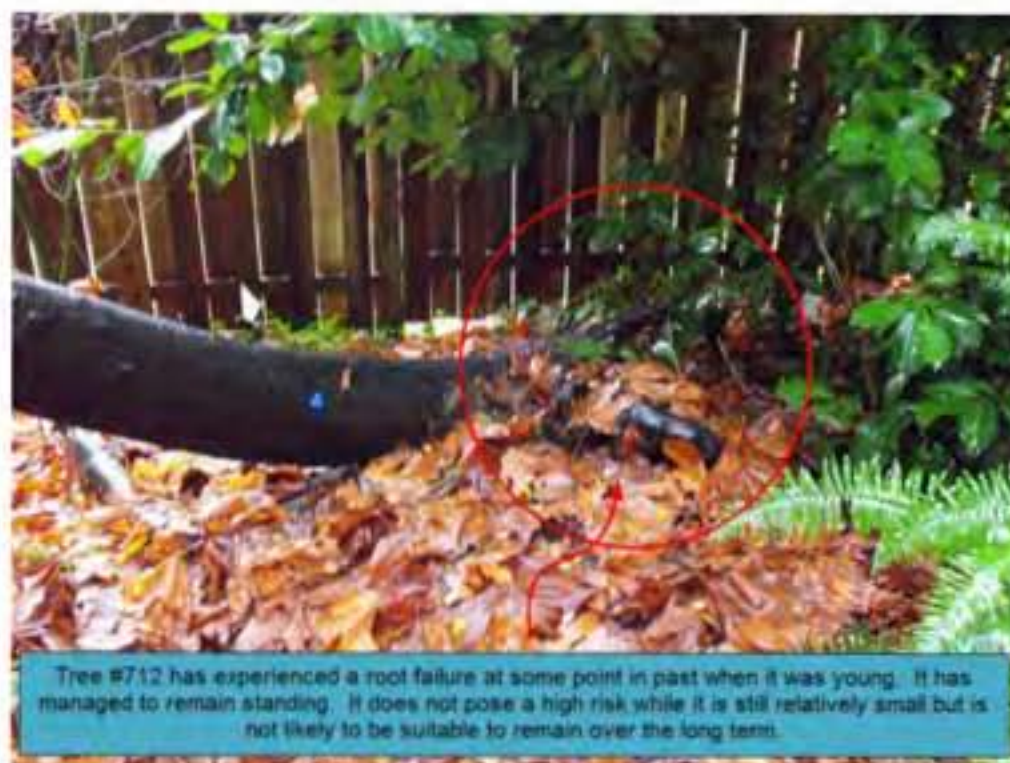
Picture 6. One tree experienced a root failure

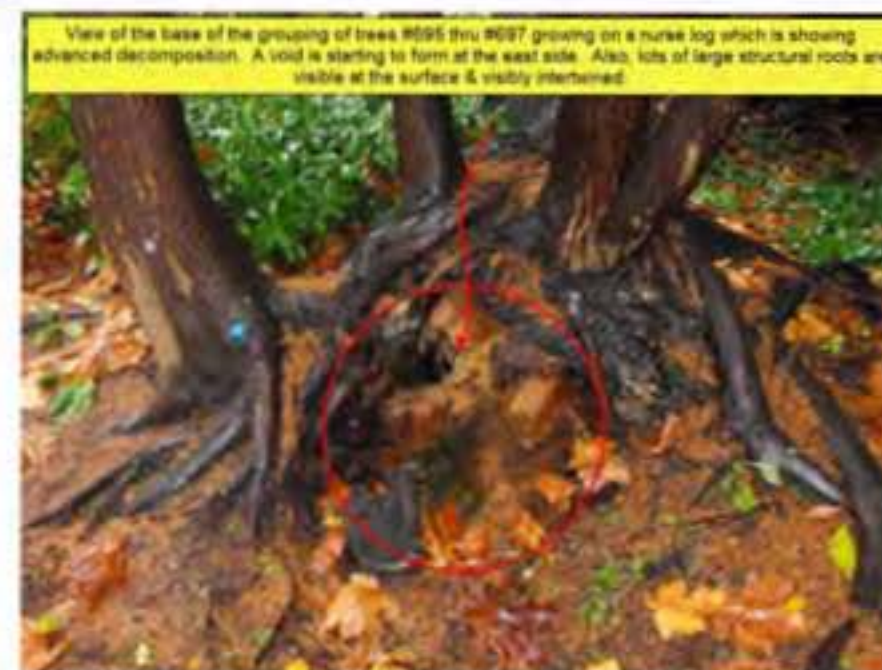
Picture 7. Lots of nurse logs/stumps on site

A *Nurse Log* is defined as a larger and decomposing fallen log or stump which acts as a germination substrate for tree species establishing in the understory in a forested environment. Such logs provide moisture, nutrients and often some degree of elevation above other potentially competing vegetation on the forest floor. However, through natural decomposition processes the nurse log breaks down over time and voids are created beneath the trees which increases the probability of root plate failures because of the atypically placement of the structural roots which tend to wrap around the nurse log.

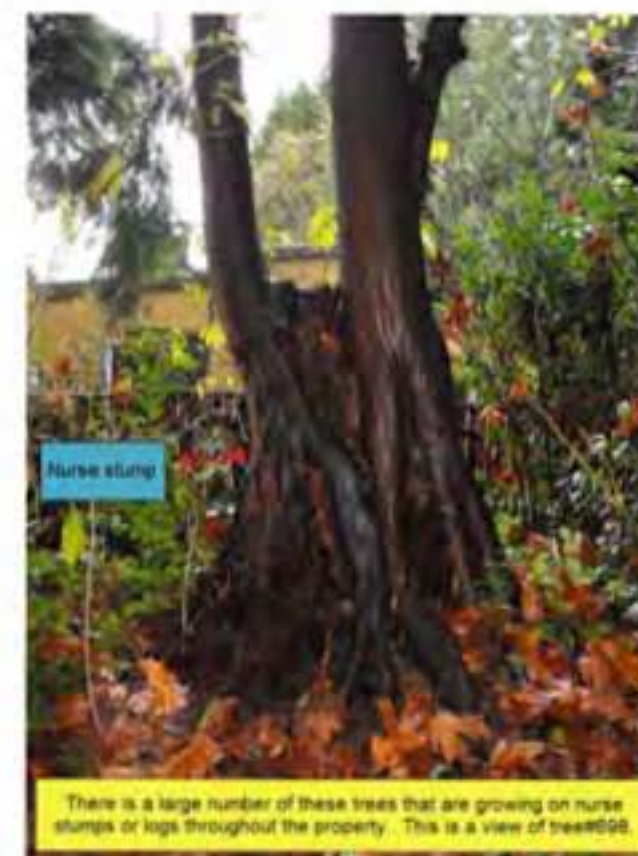
Picture 8. Lots of nurse logs/stumps on site

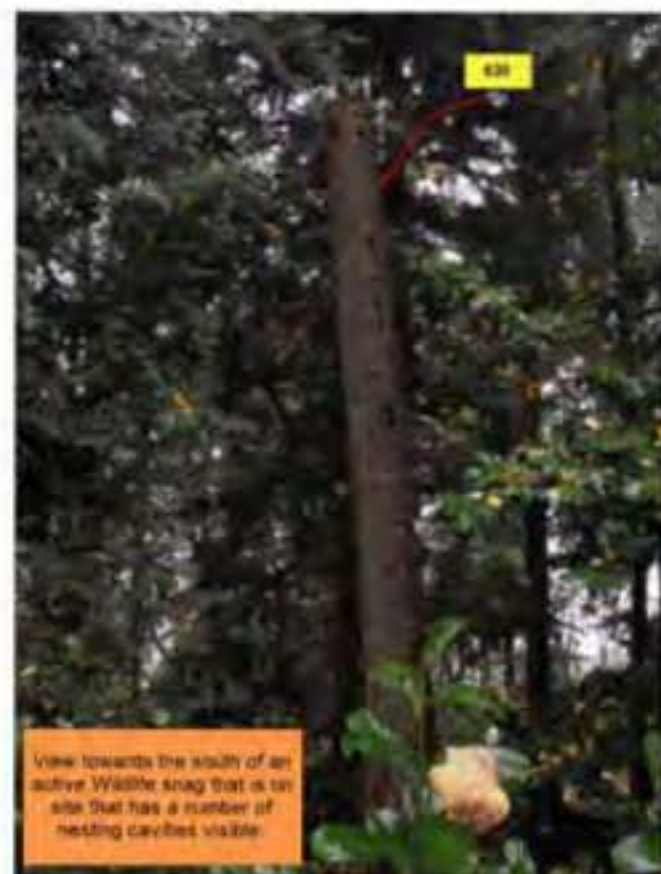
Picture 9. Active Wildlife snag

A few of these trees have been left as living stumps or wildlife snags allowing nature to take its course. *Wildlife trees* are defined as any standing dead or living tree with special characteristics that provide habitat for wildlife. They are an invaluable component in the forest ecosystem. According to the Ministry of Forests, Lands and Natural Resource Operations, there are found to be over 70 species of vertebrates and invertebrates that are dependent of the wildlife trees, for example birds, bats, insects, fungi, mycorrhizae etc.

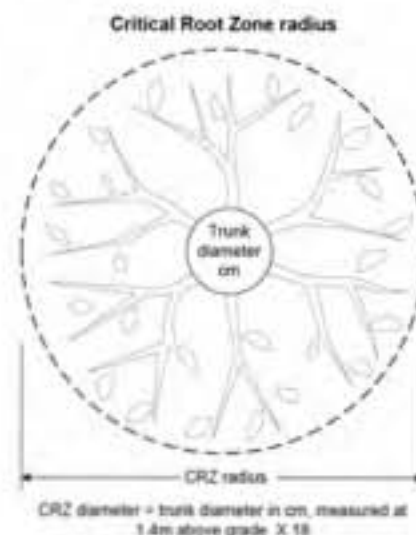
**APPENDIX 'B'****TREE PROTECTION BARRIERS FOR TREES**

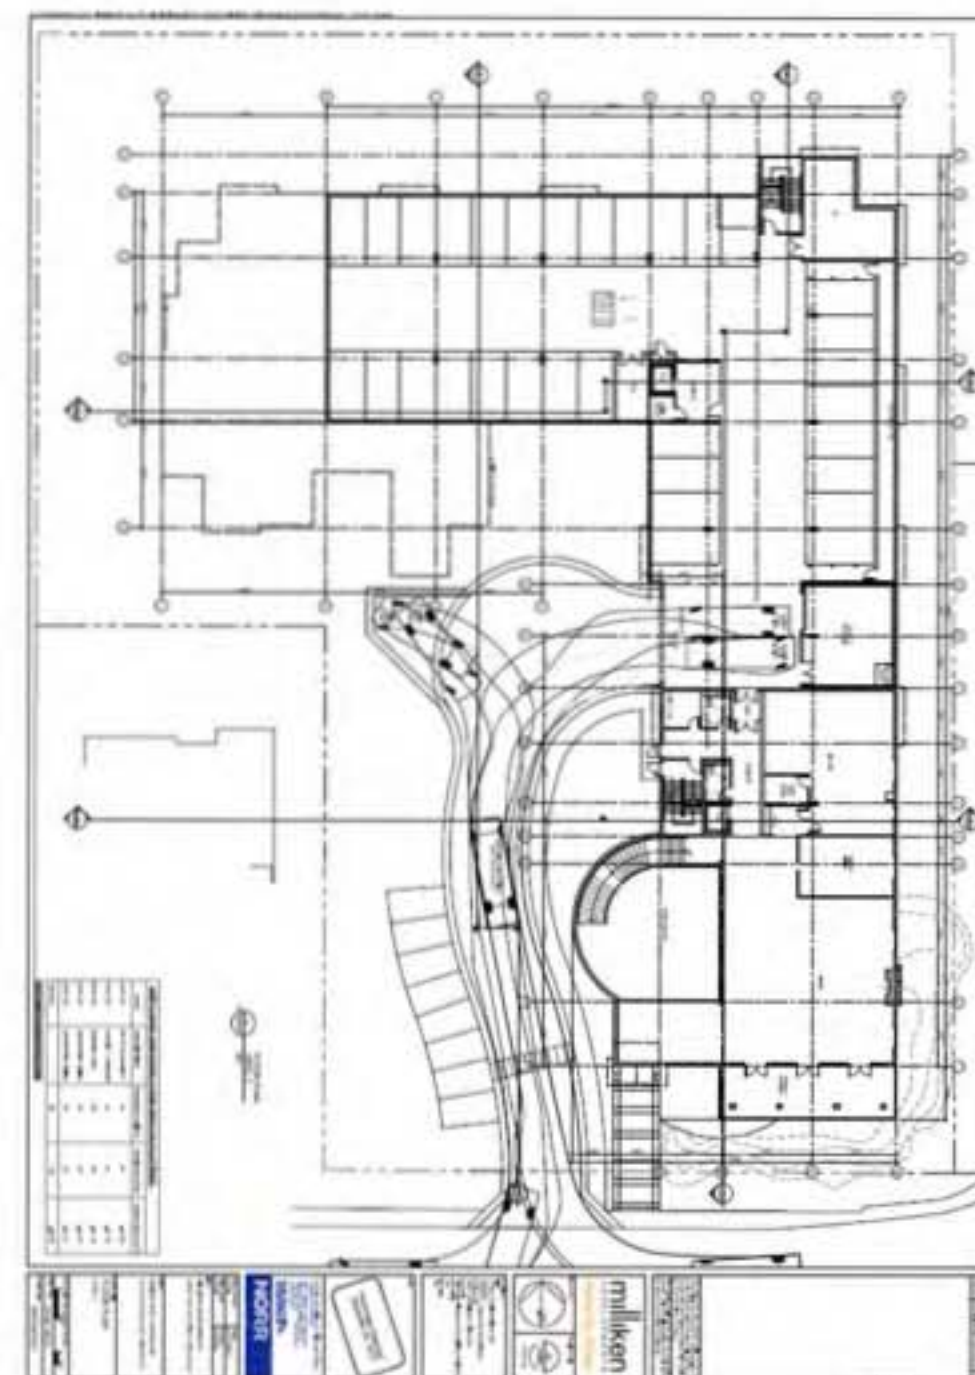
Figure 2 – Site Plan

As shown in **Figure 1**, Milliken Developments is proposing to construct a 92-suite / 110-resident (bed) Supportive Living and Memory Care community on two single-family residential lots (707 Keith Road and 525 Taylor Way) which are located in the northwest corner of the intersection of Taylor Way and Keith Road in the District of West Vancouver (District). Access to the eight surface and 32 underground parking spaces would be provided from a right-in / right-out driveway located on Keith Road (see **Figure 2**.)

As illustrated in Figure 2, key circulation elements of the site include:

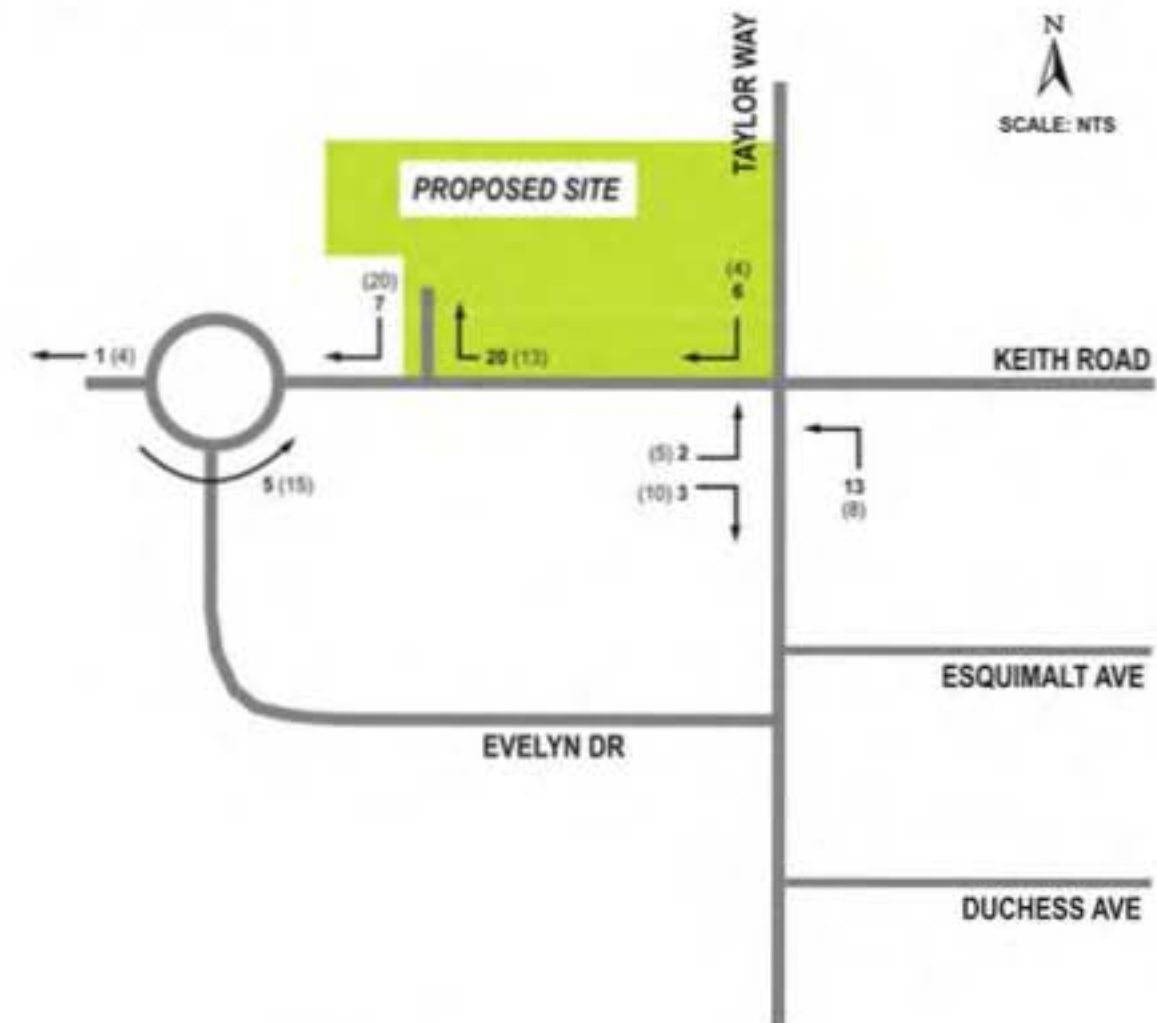
Weekday AM Peak Hour Volumes      xx  
 Weekday PM Peak Hour Volumes      (xx)

**Figure 4 – Site-Generated Traffic Volumes (at build-out)**

The assignment of site-generated traffic to the study intersection is illustrated in **Figure 4** and accounts for the right-in / right-out movements at the site driveway plus the new roundabout just west of the site at Keith Road and Evelyn Drive. Consequently, site-generated traffic must approach from Taylor Way while departing traffic has an opportunity to U-turn at Evelyn Drive in order to turn north (left) or south (right) at Taylor Way.

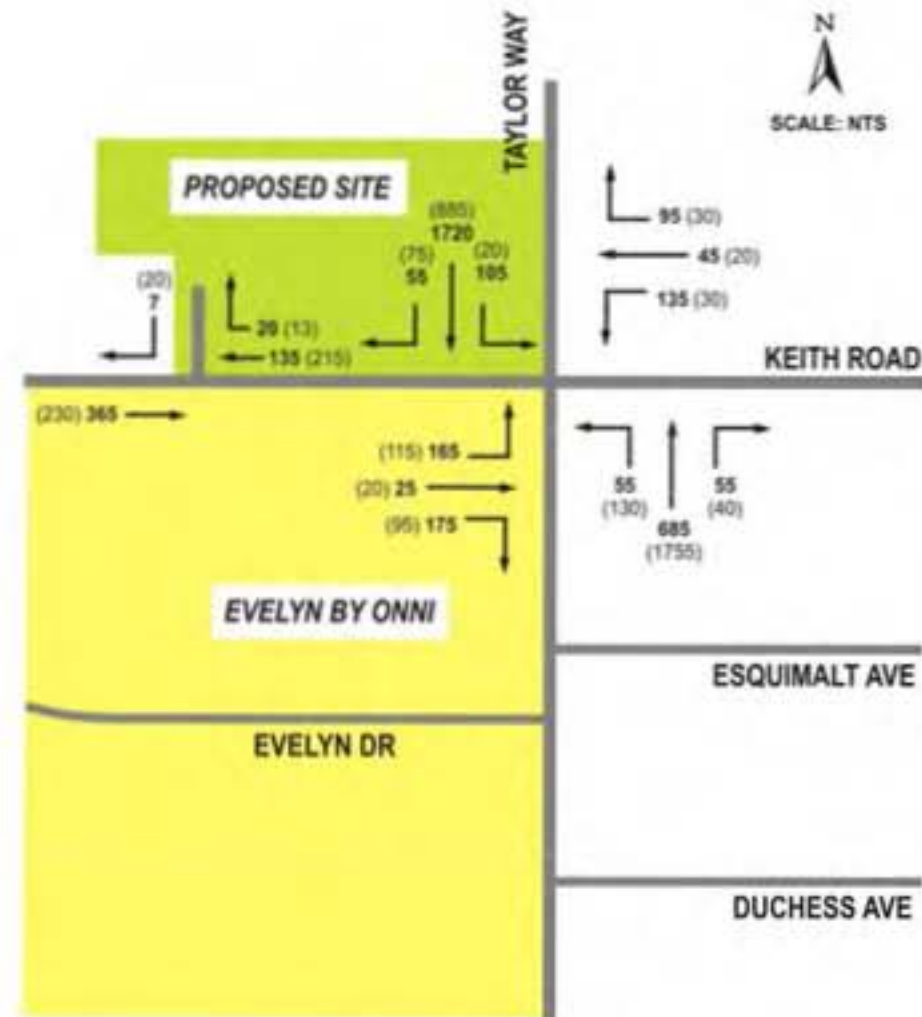
Figure 5 – Future (2022) Total Peak Hour Traffic Volumes

Future 2022 total traffic volumes were determined by adding the site-generated traffic volumes to the 2022 future traffic volumes without development. Total traffic volumes are illustrated in **Figure 5**.

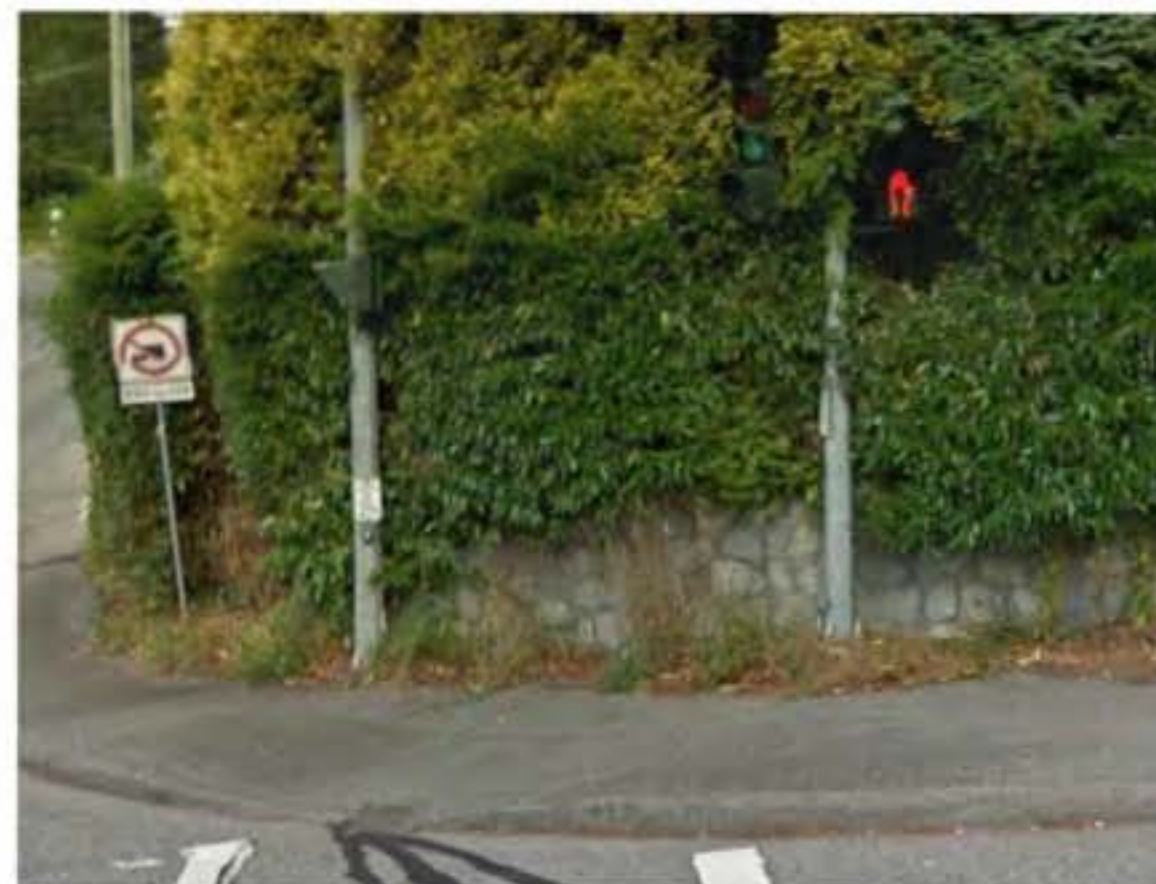
Figure 6 – Pedestrian Signals and Sidewalk on Northwest Corner of Keith Road / Taylor Way

**Sidewalk along Keith Road / Taylor Way** – sidewalk would continue to be provided along the site frontage providing opportunities for residents, visitors and staff to walk to nearby destinations, e.g. bus stops on Taylor Way, shops and services at Park Royal.

**Keith Road / Taylor Way Intersection** – this signalized intersection is equipped with push-button-actuated pedestrian signals and marked with crosswalks facilitating the movement of pedestrians across the intersection.
