District of West Vancouver

Heritage Designation Bylaw No. 5235, 2023 (1591 Haywood Avenue)

CONSERVATION PLAN
OCTOBER 2021, COMPLETED MARCH 2022
REVISED MAY 2022
INCLUDING STATEMENT OF SIGNIFICANCE

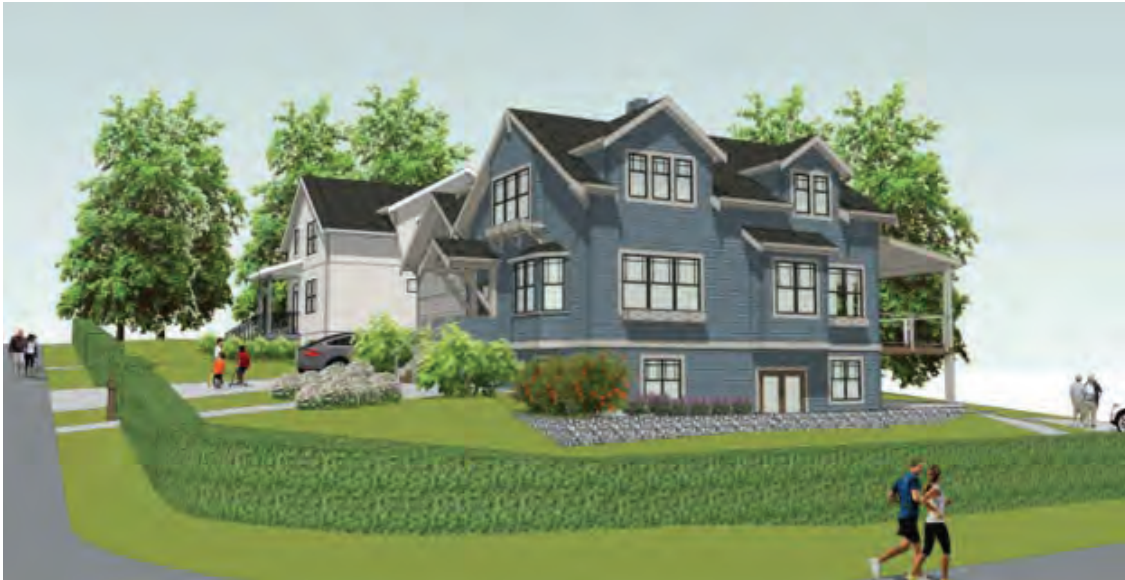
Figure 4: Rendering of the Restored Clegg House

To the extent possible, the original appearance of the Clegg House will be conserved and restored (a rendering of the restored Clegg House is shown in Figure 4). The original double hung windows will be restored, and new, hand built, wood windows will replace the non-original replacement windows. The Clegg House will retain its current orientation towards 16th Street, and the south and west elevations will remain virtually unchanged. Due to increasing the ceiling height of the basement, the house will be taller than it sits today. However, by moving the house to the south, the ridge of the roof of the house will be slightly lower due to the natural declining slope of the property. The front porch will be restored, with the existing columns removed and new roof brackets will be installed. The flower box studs will be restored and new flower boxes will be installed. The new garden level suite in the Clegg House basement will feature nine-foot ceilings, multiple points of egress, and a covered patio, creating an attractive garden level suite. The heritage conservation of the Clegg House will be carried out consistent with the recommendations of the Heritage Conservation Plan in **Appendix 'C'** (see Appendix 'B' to the proposed HRA bylaw).

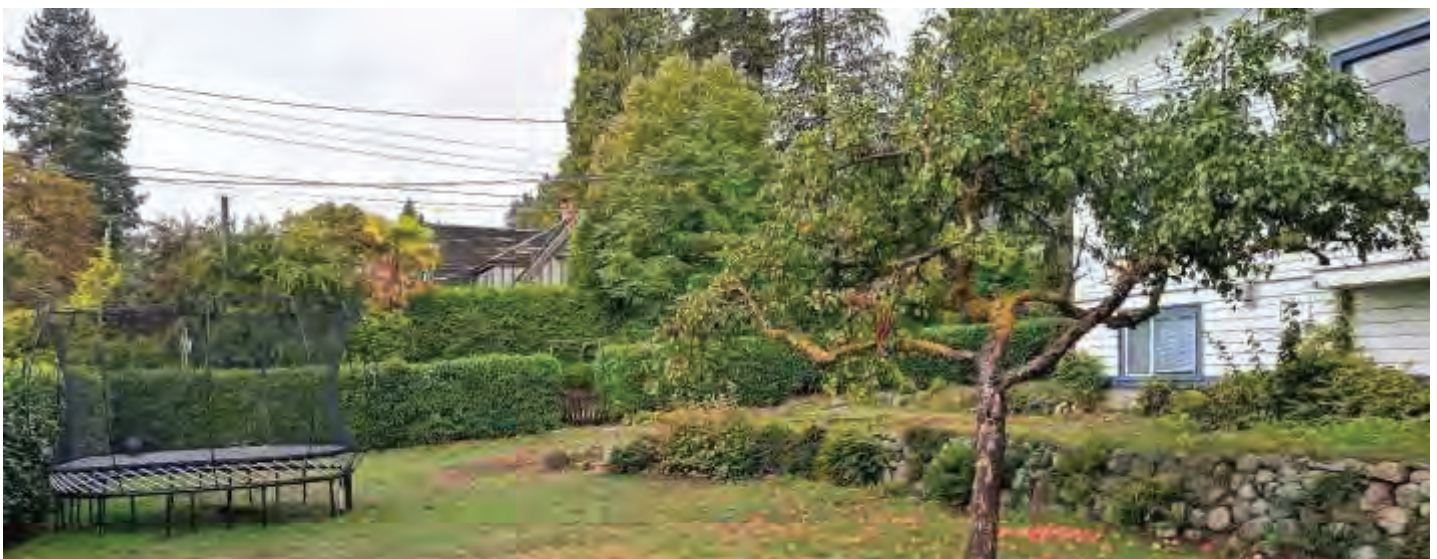
Figure 13: Side yard facing south

The Clegg House property is a deep and wide lot with a spacious ground at the corner of 16th Street and Haywood Avenue. A continuous hedge runs along the two streets. The Clegg House sits in the middle of the property. There is a separate garage structure hovering over the creek in the landscape northeast of the house. A cluster of imposing cedars trees adjacent to the driveway is standing at the northwest corner of the property and a mature apple tree on the northeast corner of the property next to the creek. The lot has a significant relationship to the Vinson Creek, complete with a rustic pedestrian bridge on the adjacent property (See appendix 6). A stone retaining wall defines the house grade from the lower portion of the side yard on the south side. An apple tree grows on the southern side yard. Generally, the grounds of the Clegg House are well kept.

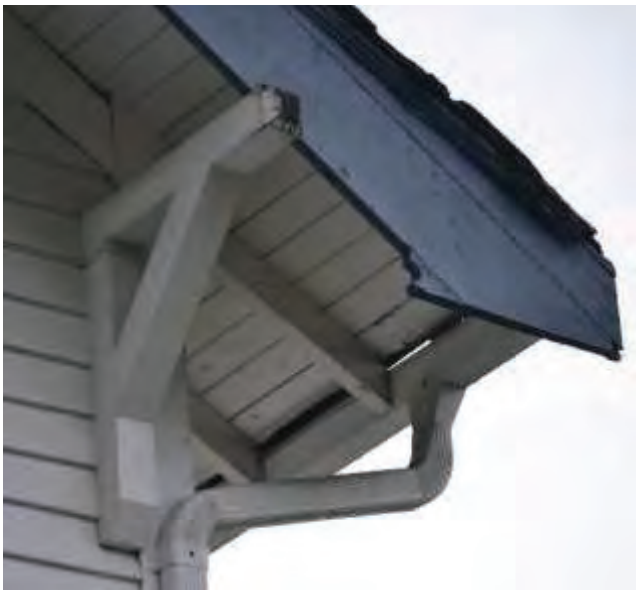
Figure 19: Open soffit with exposed rafters, bracket, and barge board

The original roofing was cedar shingles as exposed from the attic; the current vintage asphalt shingles (installed on plywood over the cedar shingles) is in fair condition. To our knowledge, at the end of its useful life. The wooden details associated with the roof include knee-brackets at gable ends with pointed end, open tongue-and-groove board soffits, exposed rafter tails, bargeboards with swollen tails, roof edge mouldings, and ridge key, headboards, and top of wall moulding. The broken framing of the roof creates a slight flair of the roof profile. The bargeboard end is swollen to cover the flair profile and its tail is augmented by the addition of wooden trim pieces. There are three knee-brackets at each gable end. The headboard makes the transition between the siding and the overhung soffit. The narrow roof fascia is hidden by eavestroughs. These wooden elements are in fair condition, although cracked bargeboards and damaged roof edge mouldings are visible throughout. Dormer, box window, and porch roofs are discussed below. The main roof is not insulated, but insulation lays on top of the second-floor ceiling. The small vent at the top of the front and back gable ends provides the only roof ventilation, which is unsightly and insufficient. The attic is accessible by a trap located in the ceiling of the second-floor hall.

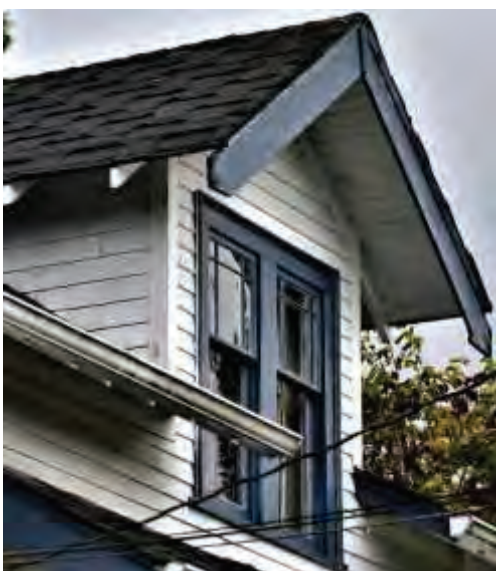
Figure 22: Shingle dormer cheek at south elevation

There are two existing gabled dormers, one on the south side and the other on the north side. Both dormers are off-centered on their respective sides. The dormers are clad with wooden lap siding with corner boards, consistent with the house siding. There is one dormer which has shingle cheeks on the south elevation. The gabled dormer roofs do not have a flare. The roof details include a generous overhang with an open soffit, tongue-and-groove boards, and exposed rafter ends. The dormer bargeboards have a downturned swollen tail similar to the main roof. Wooden lap siding is in good condition thus indicating that the overhang and flashing are effective. All dormer details appear in good condition.

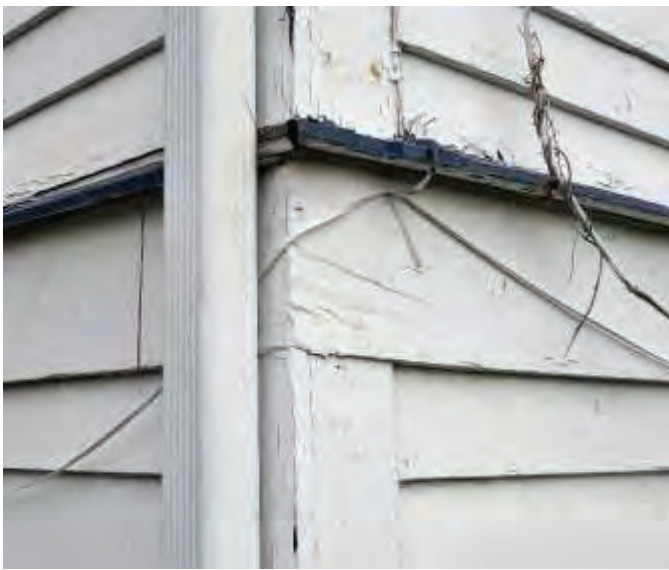
Figure 24: Lap siding, Water Table, Belt and Corner boards,

The Clegg House cladding consists of a narrow lap siding above the main floor and wider board lap siding below. The two sidings are separated by a belt board running horizontally around the house at main floor level. Corner boards define each elevation of siding. There is a continuous wooden flashing on top of the belt boards thus diverting internal water and condensation to the outside. This detail is reminiscent of a water table which is usually located on top of the foundation to protect the walls below grade. Here the flashing projects approximately two inches beyond the cladding surface. The wooden flashing is in poor condition but appears to be mostly intact. A flush plate defines the bottom edge of the siding. Little exposed foundation wall is visible below the cladding. The exposed concrete foundation is not protected. The siding and associated details are in fair condition.

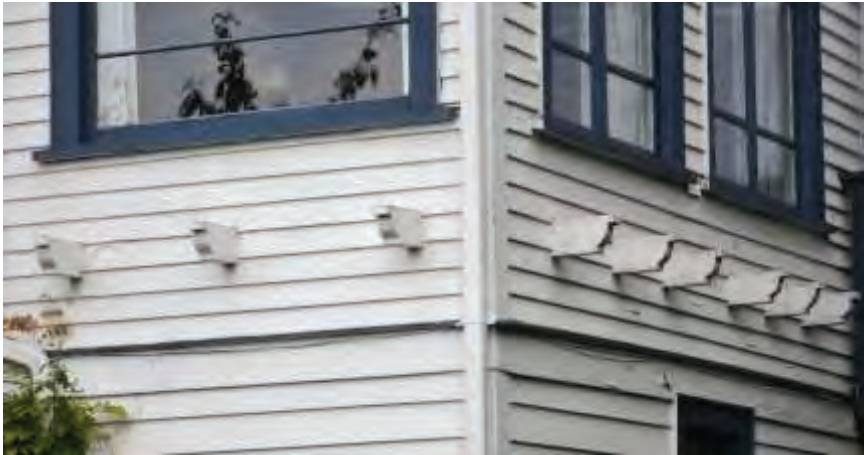
Figure 28: South and east elevation flower box studs

Flower box studs are located below the main floor windows of the south and east elevations. This is a common detail in the houses of the Late Craftsman Style; these also existed below the main and second floor windows on the front of the house as visible in *Figure 72*. The studs project beyond the exterior walls approximately 18 inches below the windowsills. The tail of the studs is shaped like a decorative bracket. Generally, these studs are in good condition.

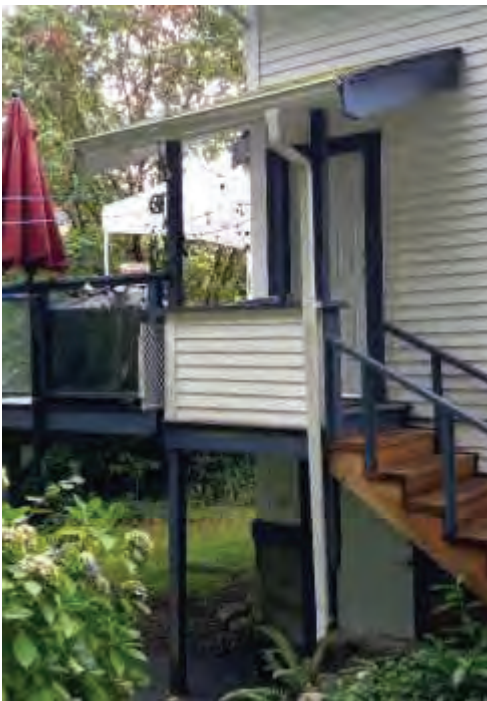
Figure 34: Back porch with roof, landing, and doors

The back porch, which provides access to the main floor kitchen, has a lean-to shed roof supported by two square columns. Details of the back porch roof include an open soffit, exposed framing, and rafters, eavestrough, bargeboards with chamfered tails, and edge moulding. A solid balustrade defines the north side of the landing. A large deck on the east side of the house is attached to the back porch landing. Closed riser stairs with a crude wooden railing runs along the north wall. The underside of the stair landing is open. The back porch and its roof are in fair condition.

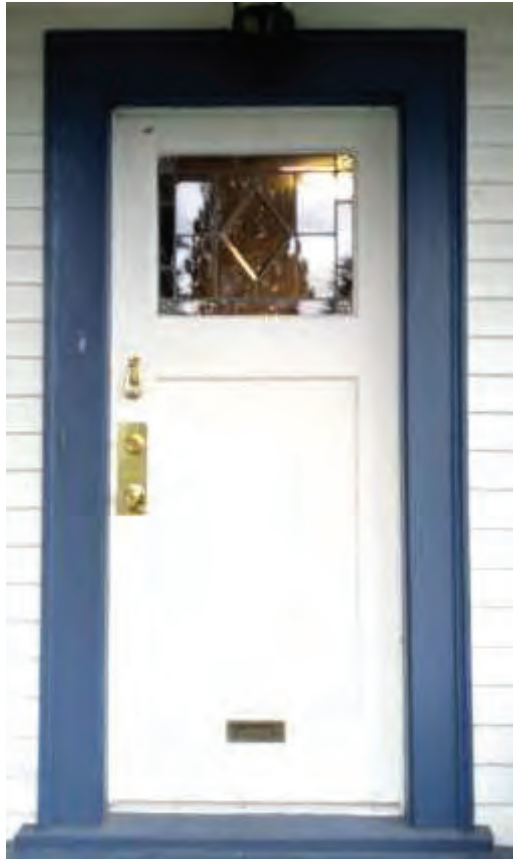
Figure 54: Front door exterior

The front door is offset on the left inside of the house, thus providing access directly to the foyer on the main floor. The door is a solid wood panelled door with an upper lite of cut-glass panes. The exterior door casing is wide with a raised sill. The interior door casing is consistent with the details of the interiors. The door assembly is in good condition. The kitchen door is a common panel door and the one to the basement is a crude contemporary door.

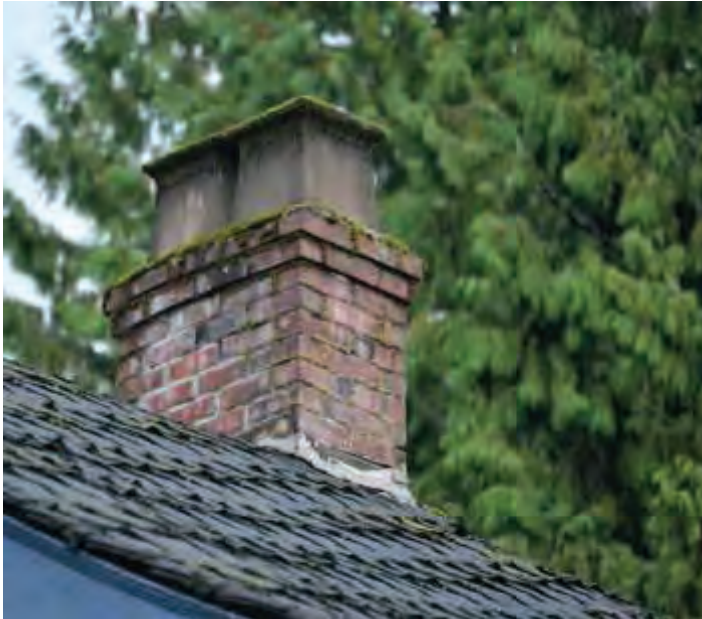
Figure 58: Internal chimney shaft above roof

The brick chimney is barely visible from the adjacent streets since it has a short, exposed shaft located in the middle of the house. The shaft above the roof is in fair condition. Moss is growing at the top of the masonry shaft and cap. The fireplace is an important feature of the main floor. The fireplace includes a decorative wood mantle. The fireplace is in good condition. The brick shaft rising through the attic has been sloppily repointed and shows signs of continued water penetration.

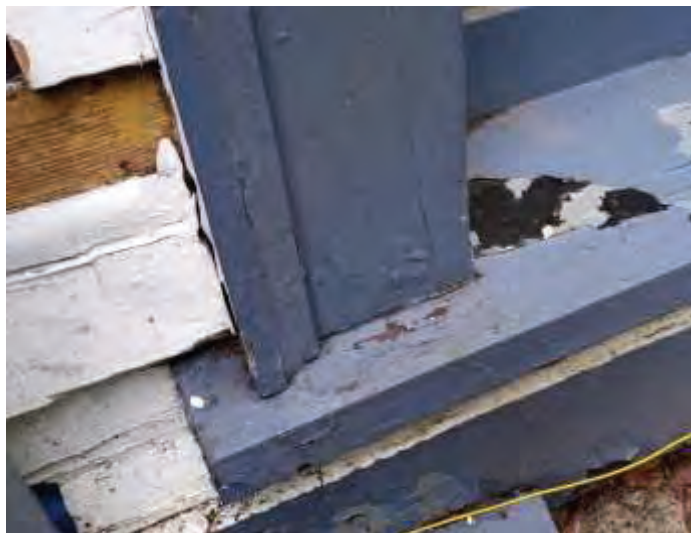
Figure 61: Black trim colour beneath the blue accent paint

The exterior paint of the siding and trim has been neglected and is generally in poor condition. Cracking and peeling are visible all over the house exterior. Original colours can be seen on the north elevation, where siding with natural look exists beneath the white coat. Black painted wood trim around windows is also visible. The black colour was common in the Victorian era, but it was not typical of the 1920's.

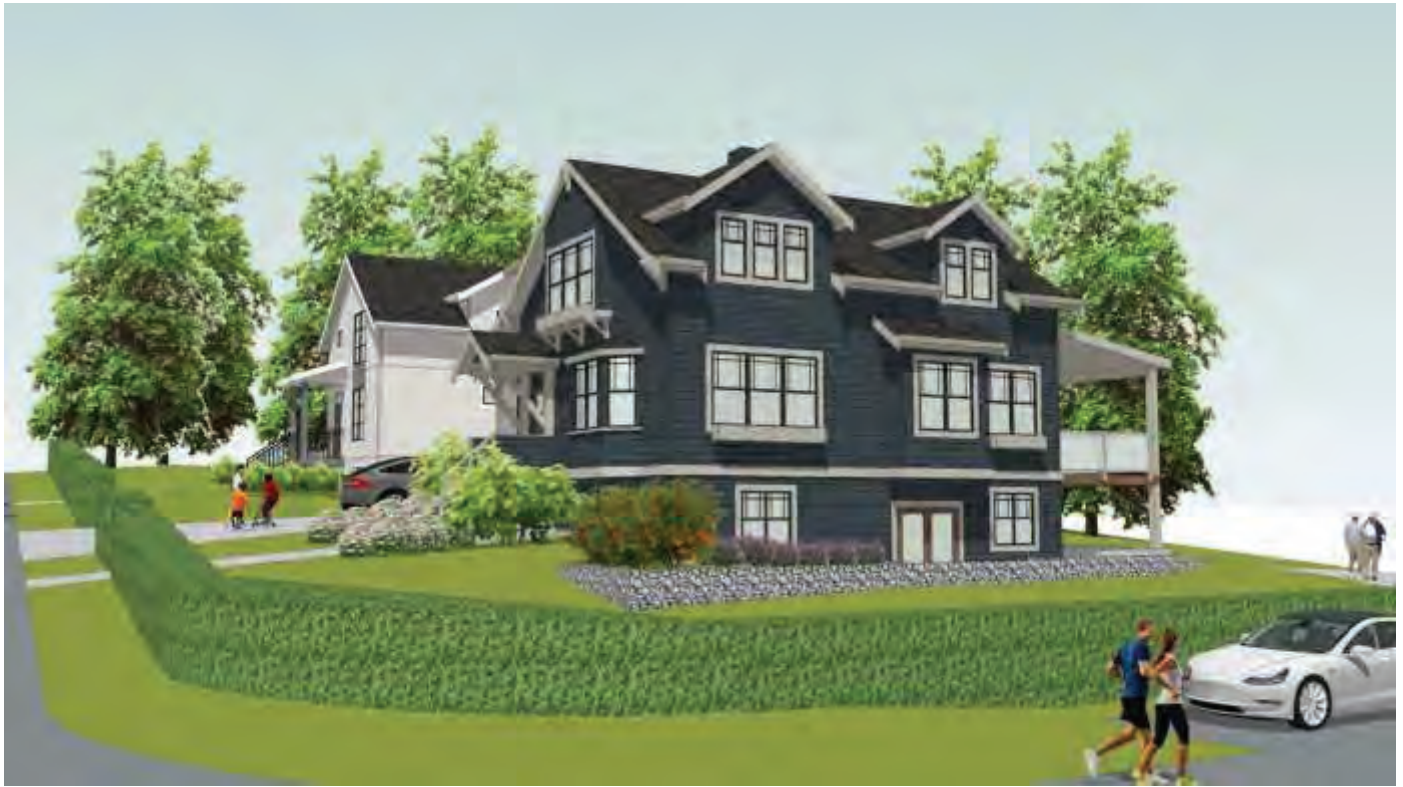
Figure 82: The Clegg House viewed from Haywood Avenue _ Focus Architectural Inc

Since the front porch will be dismantled in order to accommodate the relocation of the house, the original knee-brackets supporting its roof will be restored. The window flower boxes will be reinstated at the Clegg House, thus enhancing the exterior of the Craftsman style house. The proposed back deck staircase roof will also be restored after the moving of the house. Masonry chimneys are important character-defining elements of the Craftsman Style, and the exterior shaft of the brick chimney will be restored.

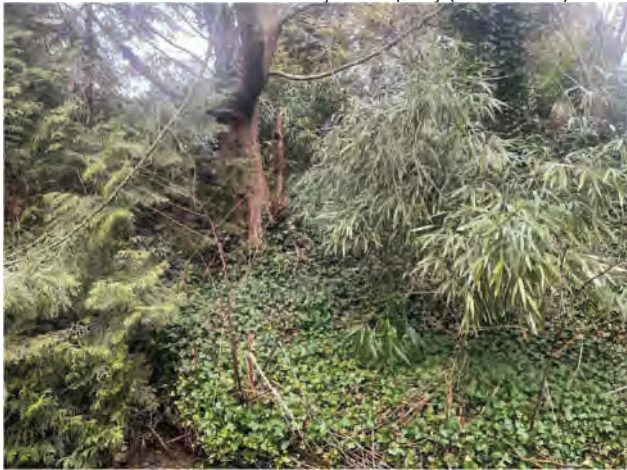
Photo 5. Northern bank – invasive species proposed for removal (2022-02-15).
