DISTRICT OF WEST VANCOUVER
750 17TH STREET, WEST VANCOUVER BC V7V 3T3

COUNCIL REPORT

Date:	May 12, 2024
From:	Jenn Moller, Director of Engineering & Transportation Services
Subject:	Eagle Island Access Infrastructure
File:	1700.09

STRUCTURE ID: 401 – MAINLAND DOCK

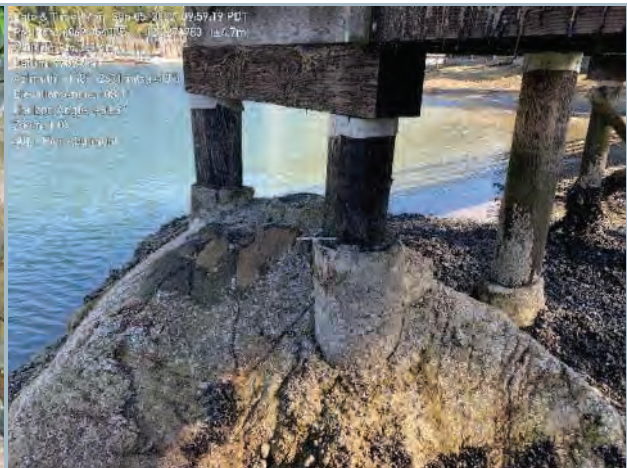
008. West Pier Abutment on Concrete Pedestal and Bedrock

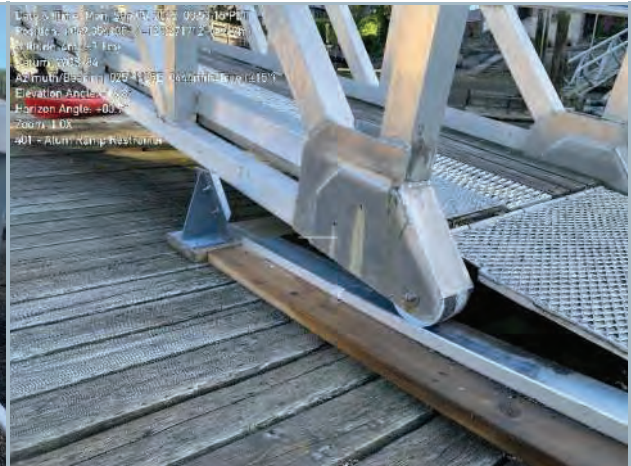
016. Gangway Slider Connection Mechanism

Pier caps require straightening from their currently rotated orientation. Replace rub rails on pile connections. Tigthen loose connection on ramp joint leading down to float or replace the bearing pin. Monitor splitting on hand rails and mid rails. Monitor longitudinal crack in Span 1 of west girder. Blackout paint on deck lights needs to be reapplied.

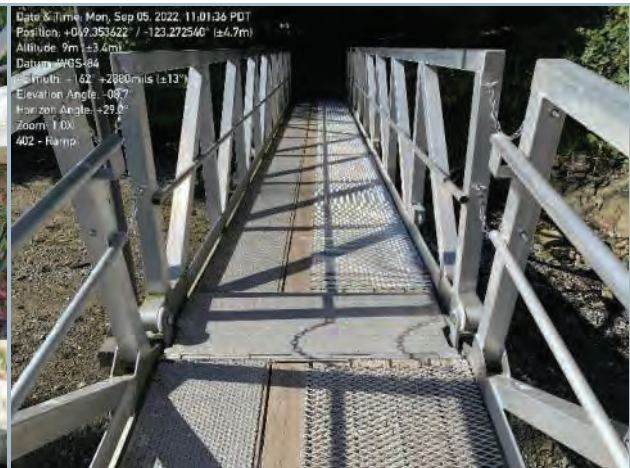
008. Aluminum Gangway Deck Tread

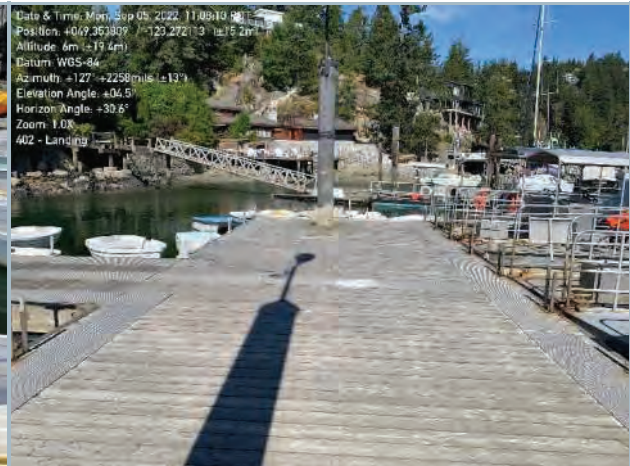
010. Deck of East Landing Dock

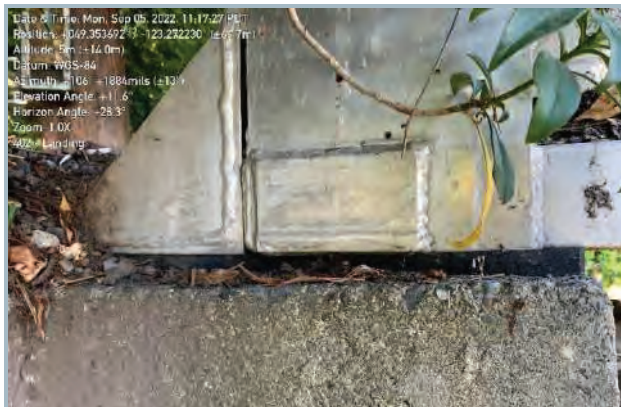
015. Shear Key at Abutment

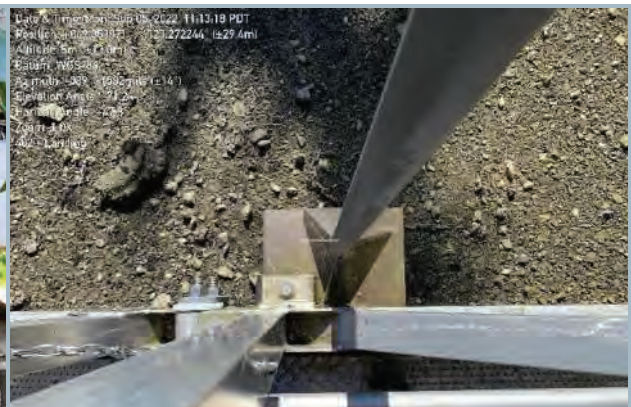
016. Anchored Pier Connection with Elastomer Bearing

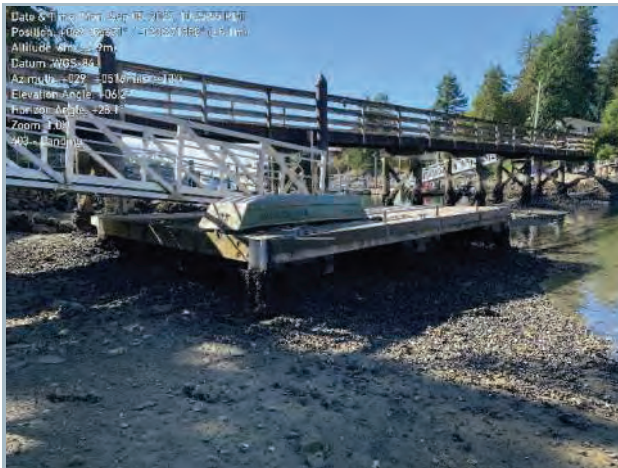
001. North Elevation

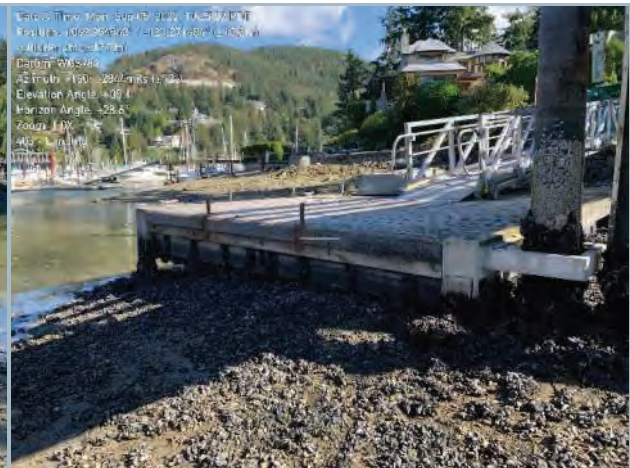
002. West Elevation

(Note Connection to Timber Pile at Southwest)

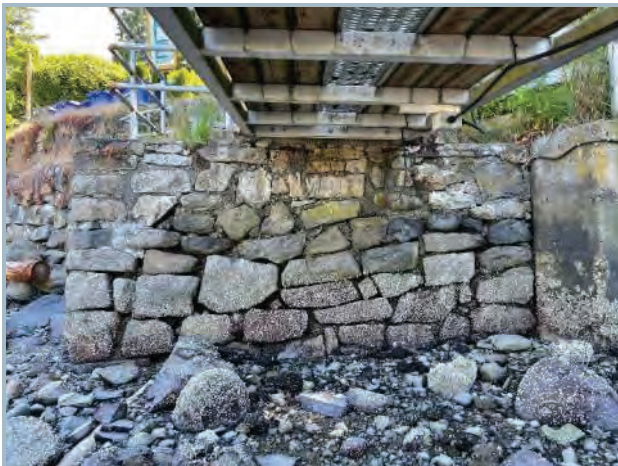
005. East Abutment

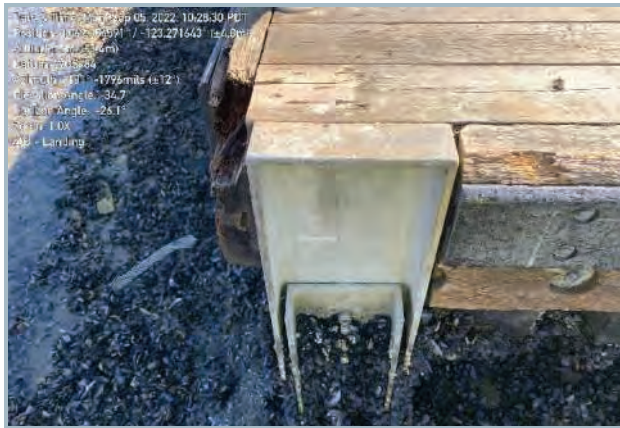
009. Dock Corner Restraint Connection, Typ.
